Ministry of Power

Northern Regional Power Committee

Subject: Minutes of 40<sup>th</sup> Protection Sub-Committee Meeting.

The 40<sup>th</sup> meeting of Protection Sub-Committee was held on **02.03.2020** at **10:00 hrs** at **NRPC Secretariat, New Delhi**. The minutes of the aforesaid meeting are available on NRPC website and same can be downloaded from <https://www.nrpc.gov.in>.

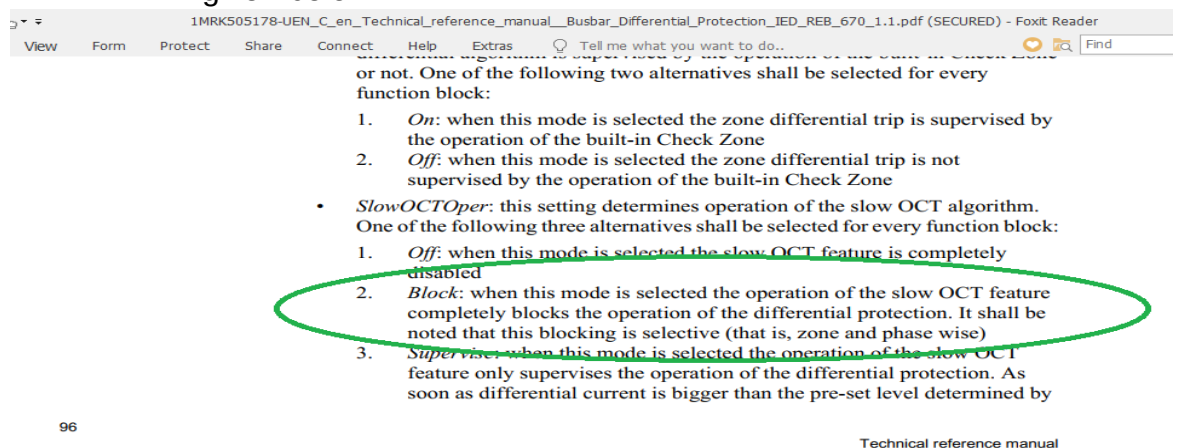
- a. Healthiness of isolator auxiliary contact shall be checked and corrected as manual operation every times may be resulted into frequent blocking of bus bar protection. Isolator auxiliary contacts shall be replaced (Action: Punjab; Time: by 15.03.2020)
- b. As per earlier general recommendation, Bus Bar Protection blocking alarm needs to be prioritized for operators and needs to be attended on priority. Recommendations approved in earlier PSC meetings shall be adhered to by all the utilities. (Action: Punjab & other NR utilities)
- c. Healthiness of station event logger details shall be ensured at 220 kV Malerkotla (Punjab). (Action: Punjab; Time: by 15.06.2020)
- d. Lesson Learnt:
  - Wherever, REB 670 bus bar differential protection implemented there is three different options available as given below

- Slow OCT features shall be used only for supervision not for blocking of bus bar differential protection.

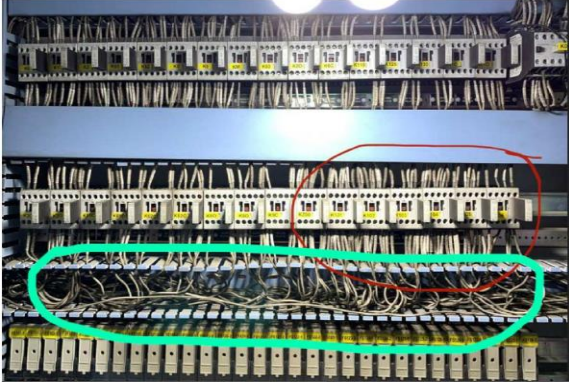
**POWERGRID details (Reason for tripping)**

- One of the 7 contactors, K101 mal-functioned.

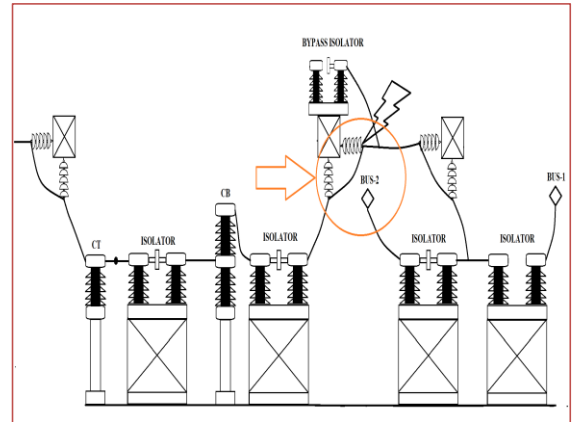
## Fault Event

- R-phase insulator string (Before CB, i.e. Bus side) of 220 kV Malerkotla – Dhuri circuit No. 2 snapped.
- Weather conditions : Heavy rain & winds
- Jumpers fell on Busbar-2 leading to Bus-bar fault.

- In future cleaning/ strengthening of insulators with silicon RTV coating etc. has been suggested to O&M staff.
- To make isolator auxiliary switches healthy to avoid human error.
- Settings changed from "BLOCK" to SUPERVISE so that whenever Id crosses threshold value the scheme will operate irrespective of BLOCK.
- To educate the operating staff regarding intimating to S/S incharge

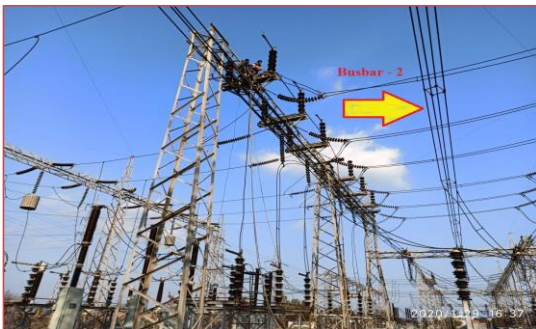
## Damaged segment passing over Busbar-2
