Subject: Agenda for 38th Protection Sub-Committee Meeting.

Agenda for
38th Meeting of Protection Sub-committee of
Northern Regional Power Committee

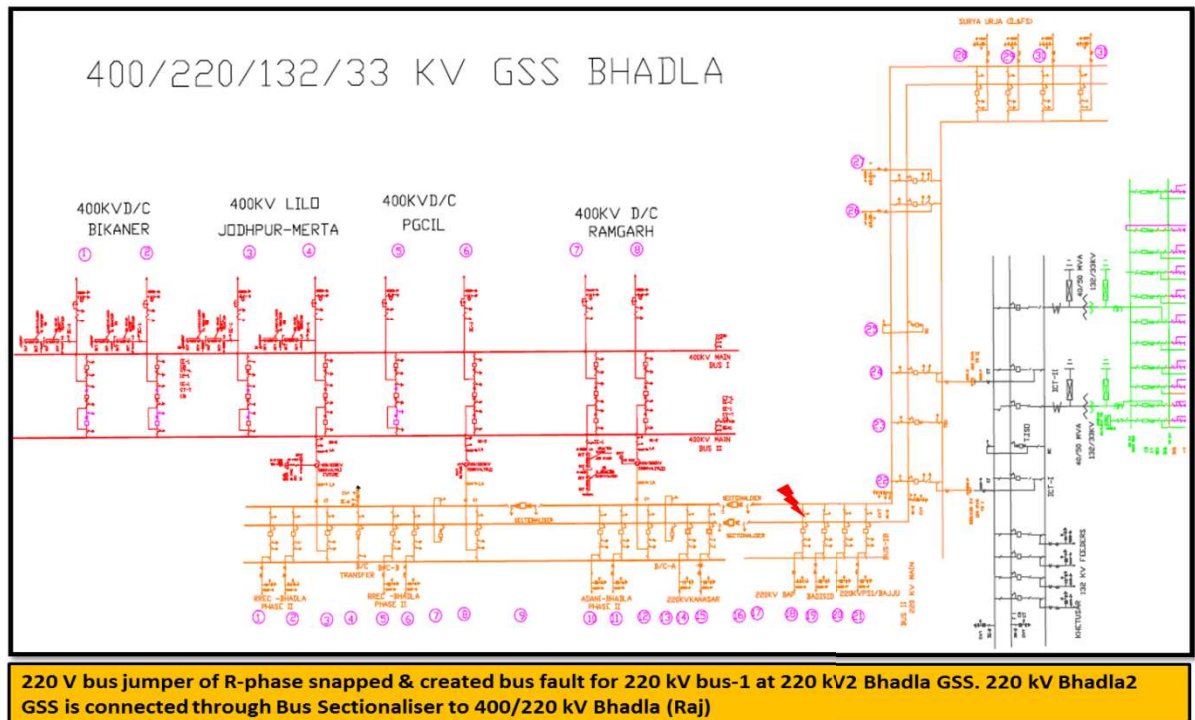
1. Connectivity diagram of 400/220 kV Bhadla (Raj):

- 400/220 kV Bhadla (Raj) station has one and half breaker scheme. It is connected through Bikaner D/C, Ramgarh D/C, Bhadla (PG) D/C, Jodhpur S/C and Merta S/C. It also has three 500 MVA 400/220 kV ICTs. At 220 kV side of 400/220 kV Bhadla (Raj), it is connected with 220 kV RSDCL D/C, 220 kV ARERPL, 220 kV Kanasar ckt and 220 kV Bhadla2 GSS through 220 kV Bus Sectionalisher. 220 kV Bhadla2 GSS further connected with Bap S/C, Badisid S/C and Surya Urja D/C. Bhadla station is connected to solar park.

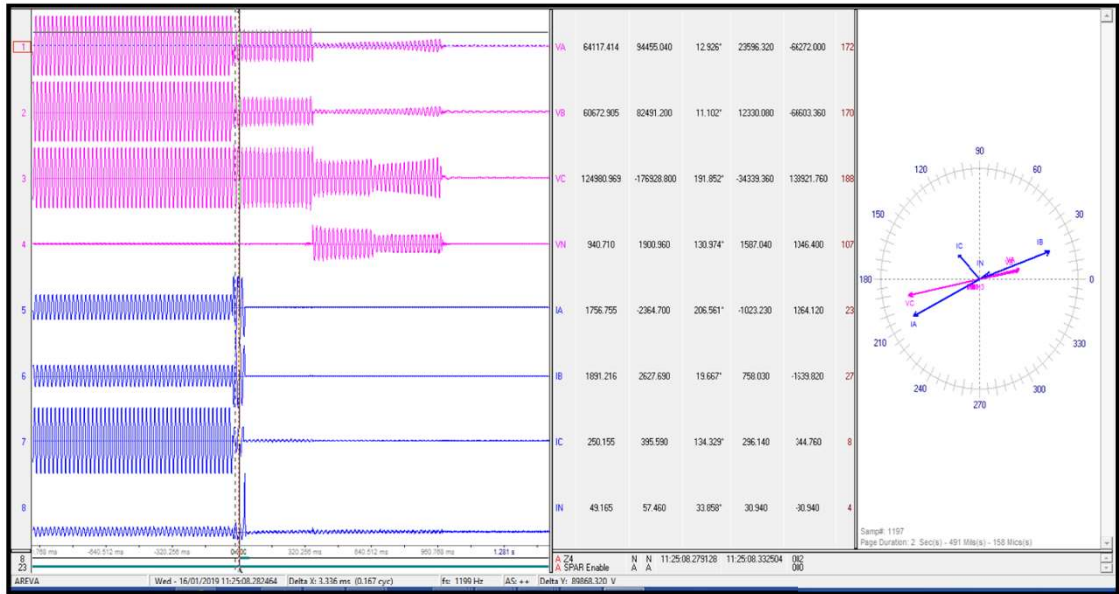
DR of 220 kV Bhadla GSS (end)-Badisid ckt

Maximum fault current in R&Y-phase
Time Synchron error

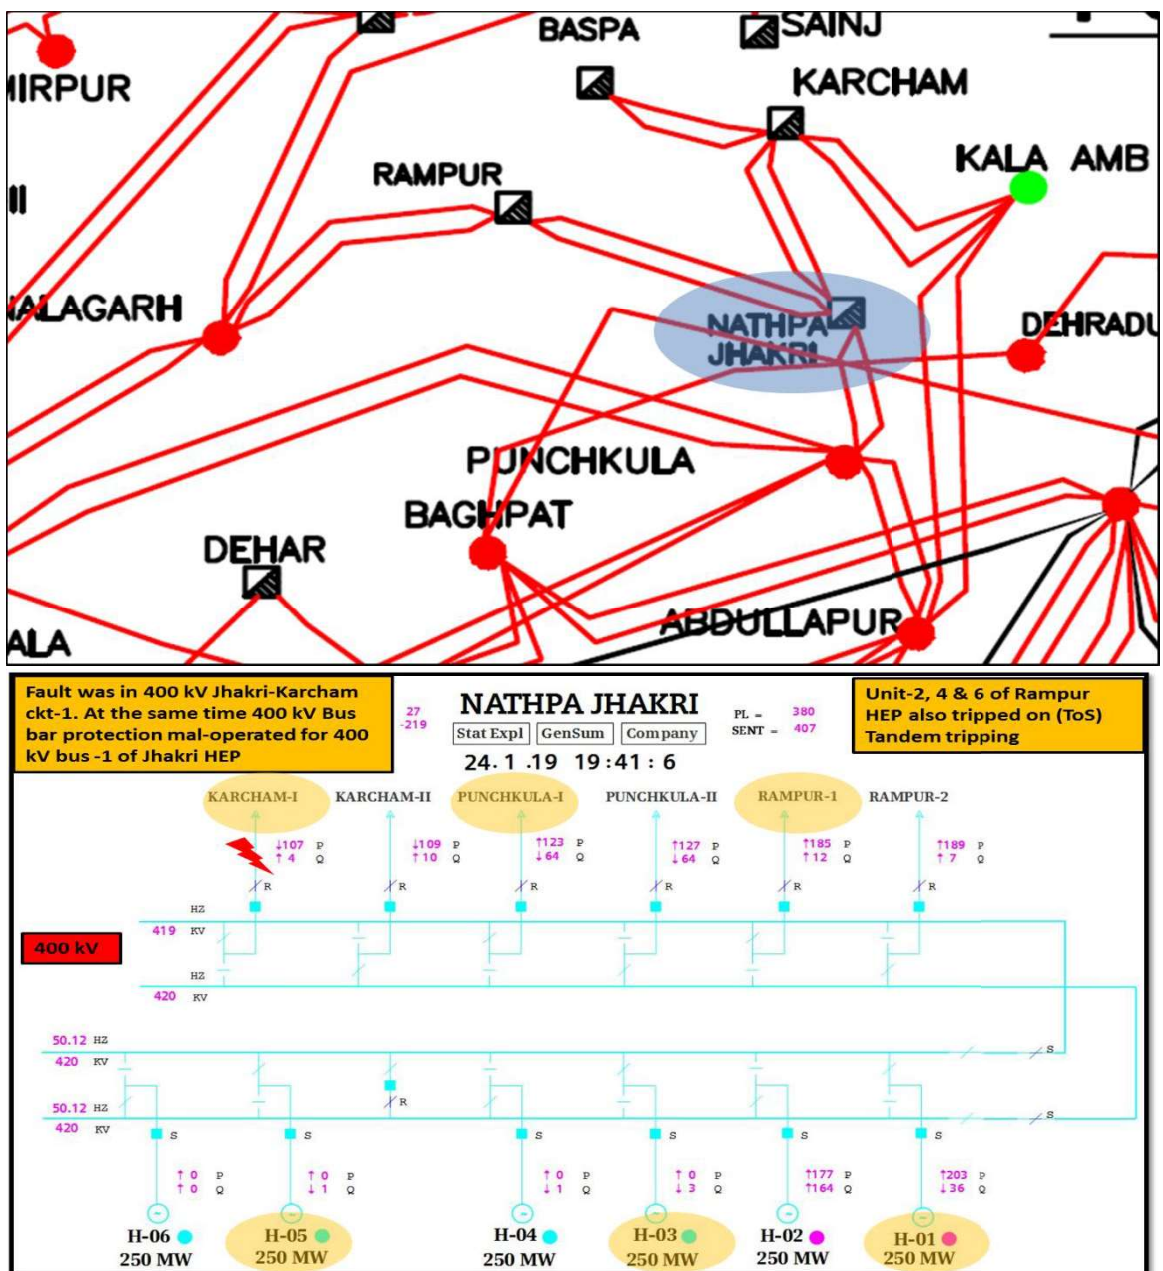
1. Connectivity diagram of 400 kV Jhakri HEP:

2. 400 kV Jhakri HEP station has double main single breaker bus scheme. It is connected through Karcham D/C, Rampur D/C and Panchkula D/C. It also has six units of 250MW.

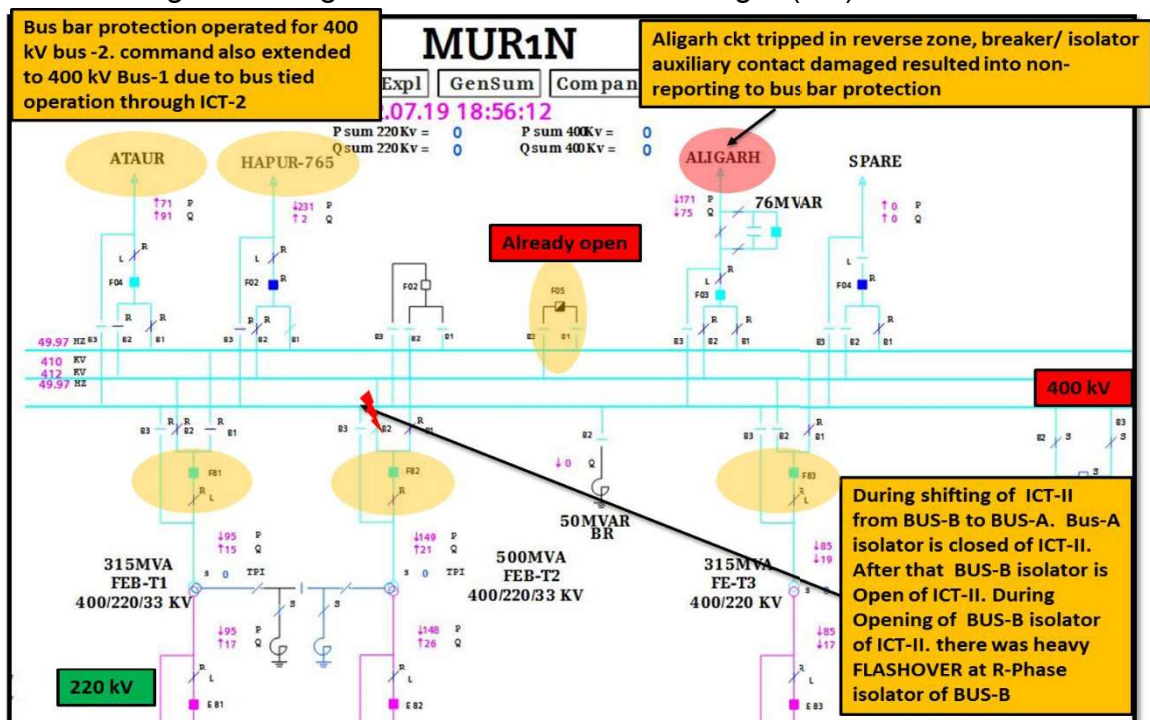
1. Single line diagram of 400/220 kV Muradnagar (UP):

2. 400/220 kV Muradnagar (UP) station has DMT (double main transfer breaker) scheme. It is connected through Ataur S/C, Aligarh S/C and Hapur S/C. It also has two 315 MVA & one 500MVA 400/220 kV ICTs.

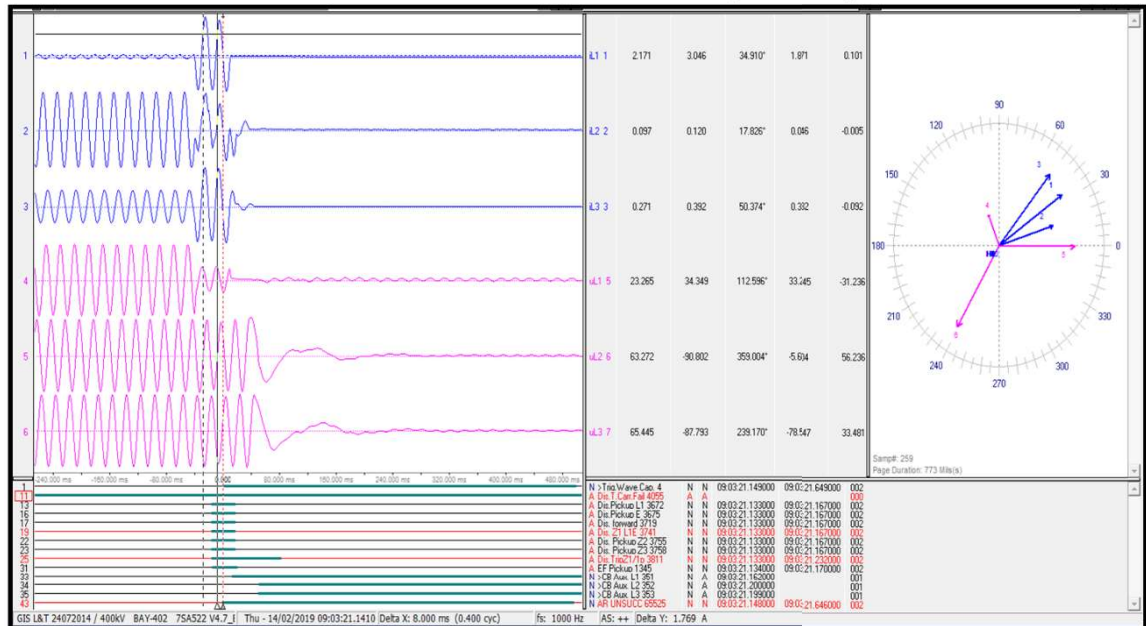
DR of 400 kV Harsh Vihar (end)-Dadri ckt

- Line tripped in Z-1 without A/R attempt
- Communication channel failed

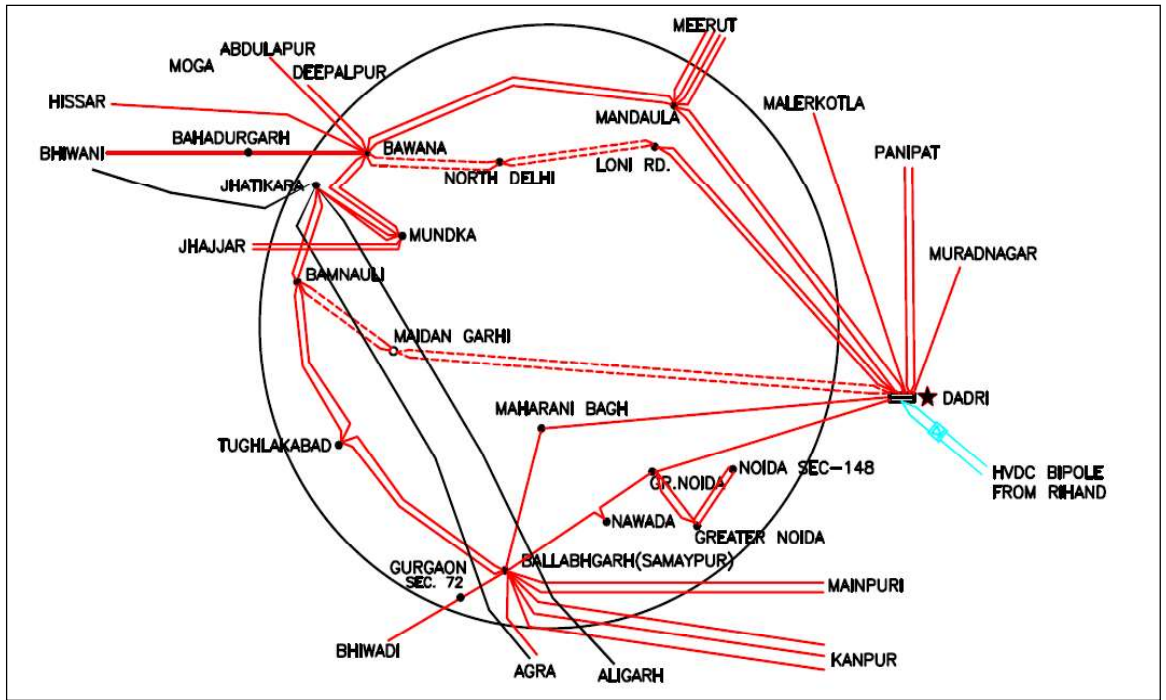
17. Connectivity diagram of Ballabgarh(PG):

18.400/220kV Ballabghar(PG) is connected at 400kV through Kanpur(PG) 3 ckts (with FSC), Maharani Bagh(PG), Nawada(HVPNL), Mainpuri(PG) D/C, Agra(PG), Gurgaon(PG) and Tughlaqabad(PG) D/C. It has one and a half breaker bus bar scheme. Recently, a series reactor has also been installed between bus-1 and bus-4. There are a total of 4 buses wherein two have sectionaliser isolator which is kept open during normal operation.

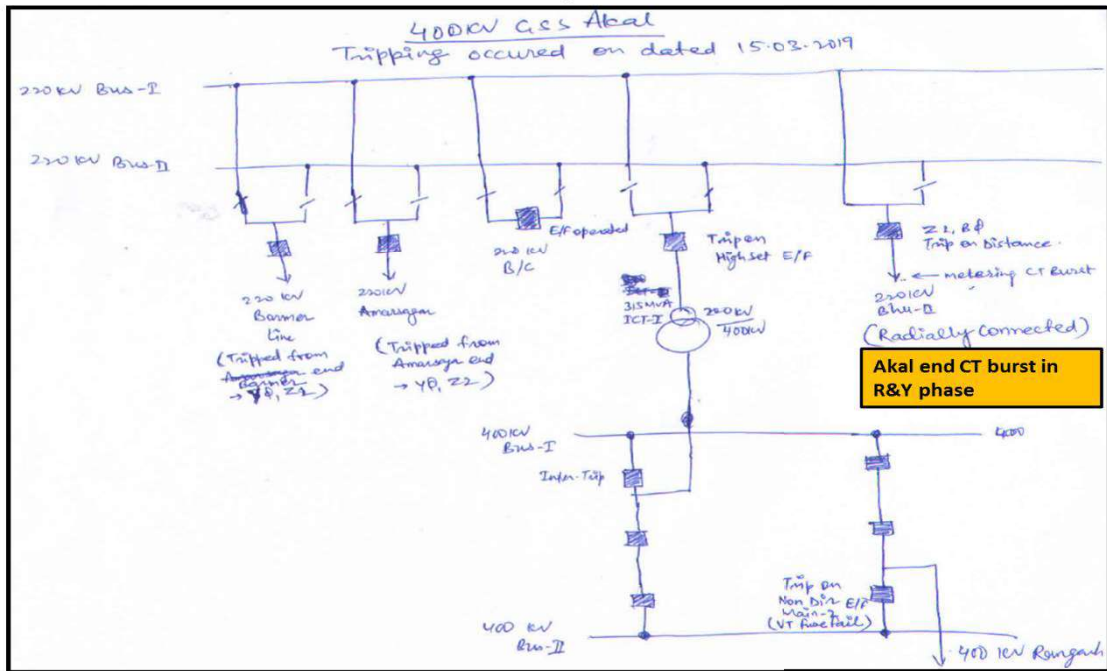
Affected area of 400/220 kV Akal station

2. 400/220 kV Akal (Raj) station has one and half breaker scheme at 400 kV side. It is connected through Kankani D/C, Ramgarh D/C, Barmer S/C and Jodhpur S/C. It also has three 315 MVA 400/220 kV ICTs & one 500MVA 400/220 kV ICT.

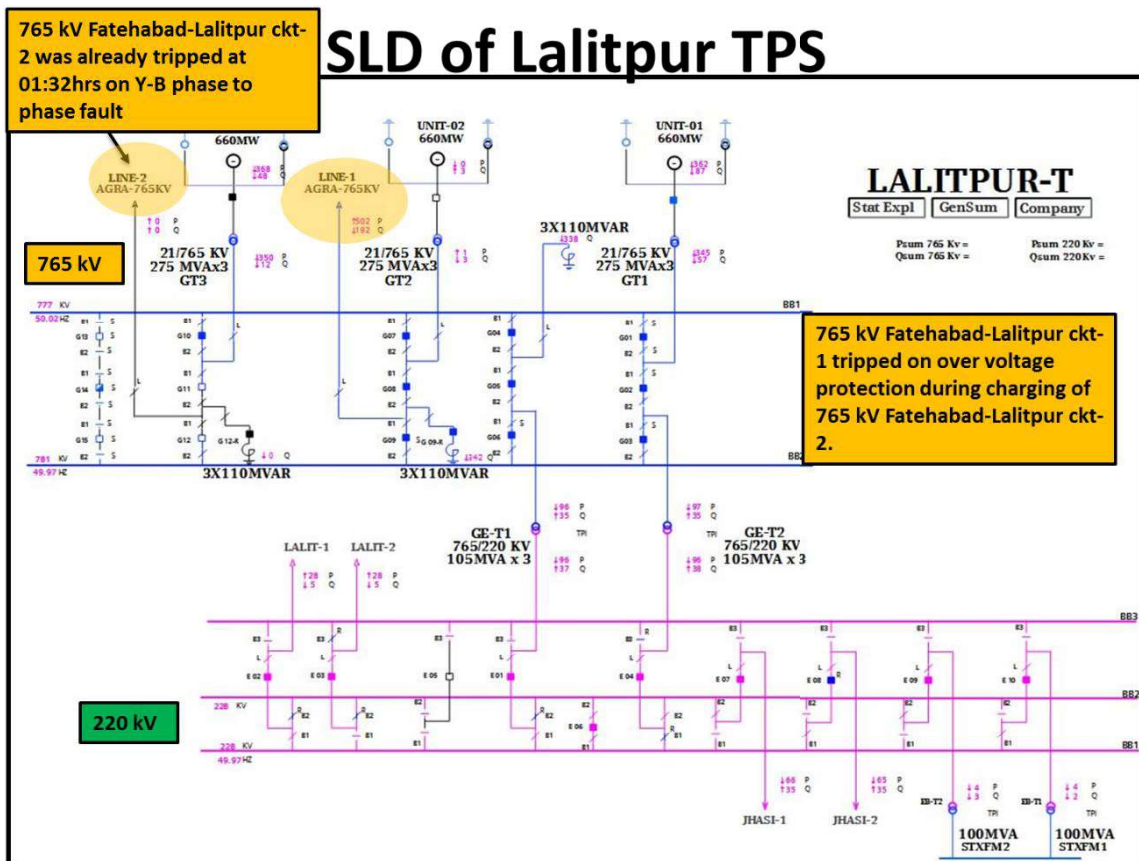
1. Single Line Diagram of 765/220 kV Lalitpur TPS:

2. 765/220 kV Lalitpur SCTPS has one and half breaker scheme. It is connected through 765 kV Fatehabad D/C. It also have two 315 MVA 765/220 kV ICTs. At 220 kV voltage level, it is connected through Jhansi D/C and Lalitpur D/C local.

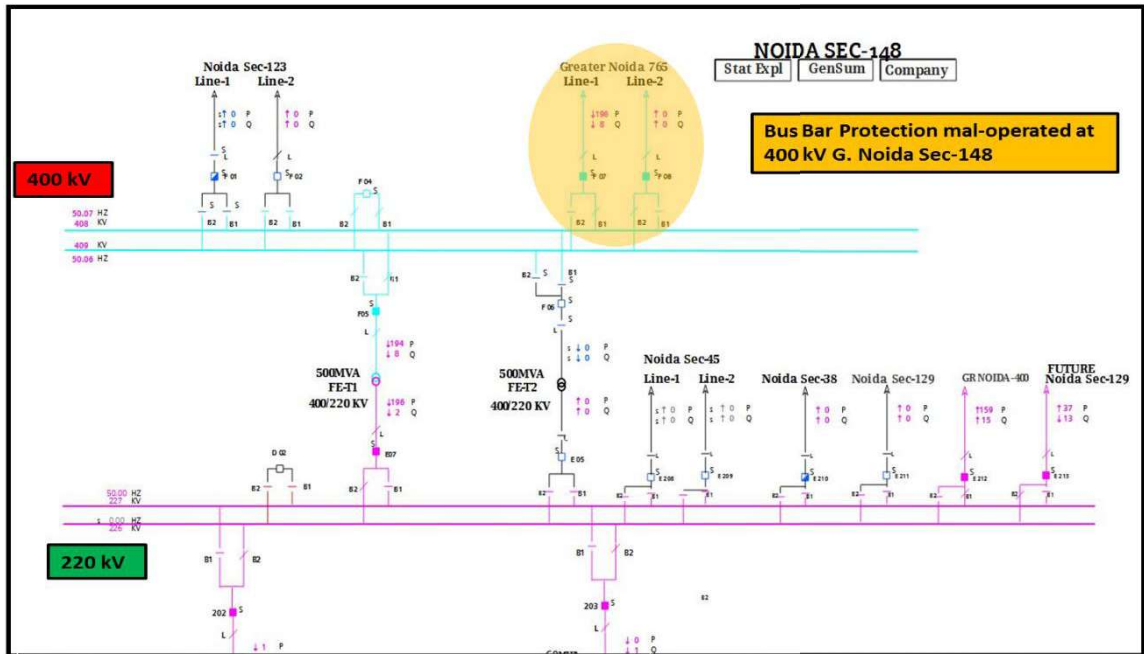
SLD of 400 kV Noida Sector-148 (UP)

2. At 400/220 kV G. Noida Sector-148 (UP) station have double main transfer breaker scheme. It is connected through G. Noida (765/400 kV) D/C. It also have two 500 MVA 400/220 kV ICTs.

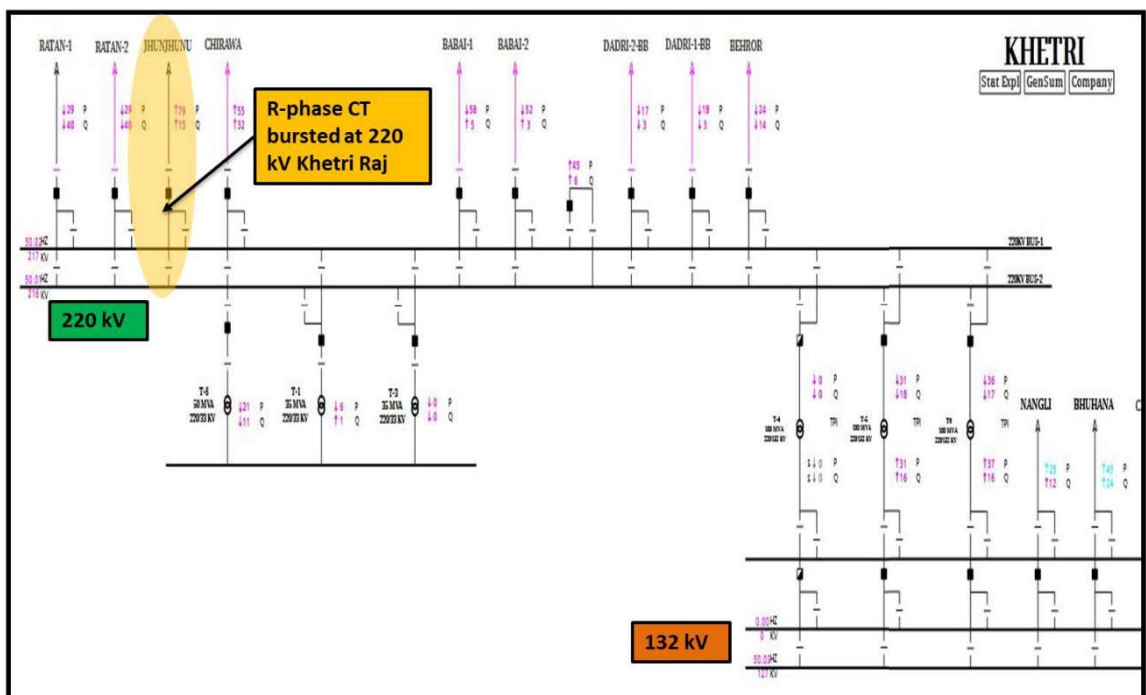
1. Single Line Diagram and Connectivity diagram of 220 kV Khetri (Raj):

2. 220 kV Khetri (Raj) station has double bus single breaker scheme. It is connected through Charkhi Dadri BBMB D/C, Ratangarh D/C, Babai D/C, Chirawa S/C, Jhunjhunu S/C and Behror S/C. It also has three 100 MVA 220/132 kV ICTs and 2*35+1*50 MVA 220/33 kV ICTs.
3. In antecedent conditions, 220 kV bus bar protection was not healthy at 220 kV Khetri (Raj) and alternate arrangement for bus

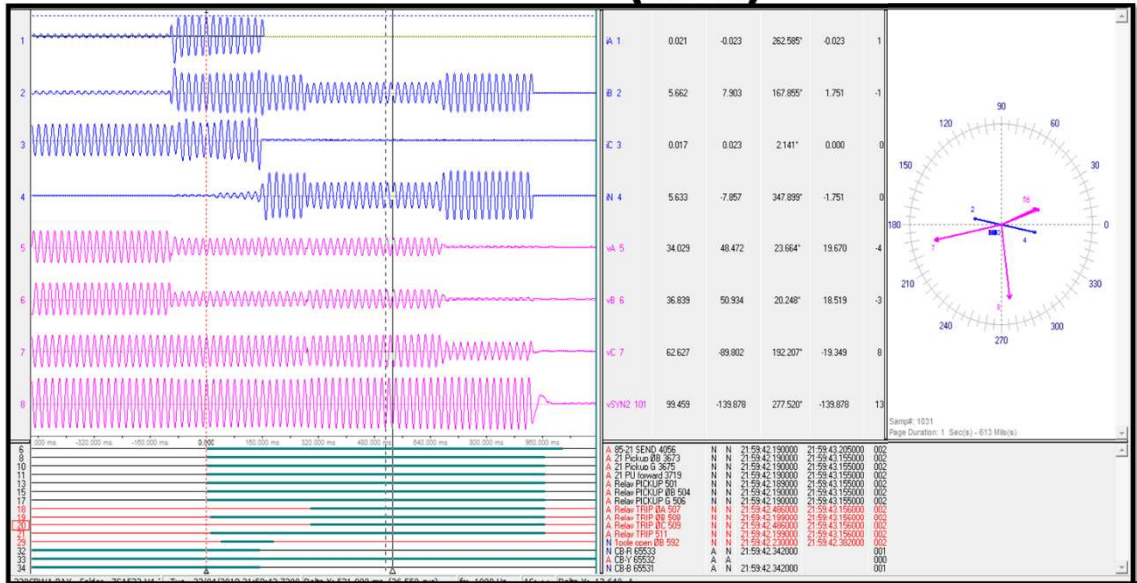
DR of 220 kV Khetri (end)-Chirawa ckt

Time Sync Error
 Y-N fault, A/R blocked. Tripping command issued for all three phase, Y-phase breaker didn't open. It resulted into LBB protection operation and delayed clearance of fault. **Bus bar blocked**
 One of the ckt tripped in Z-3

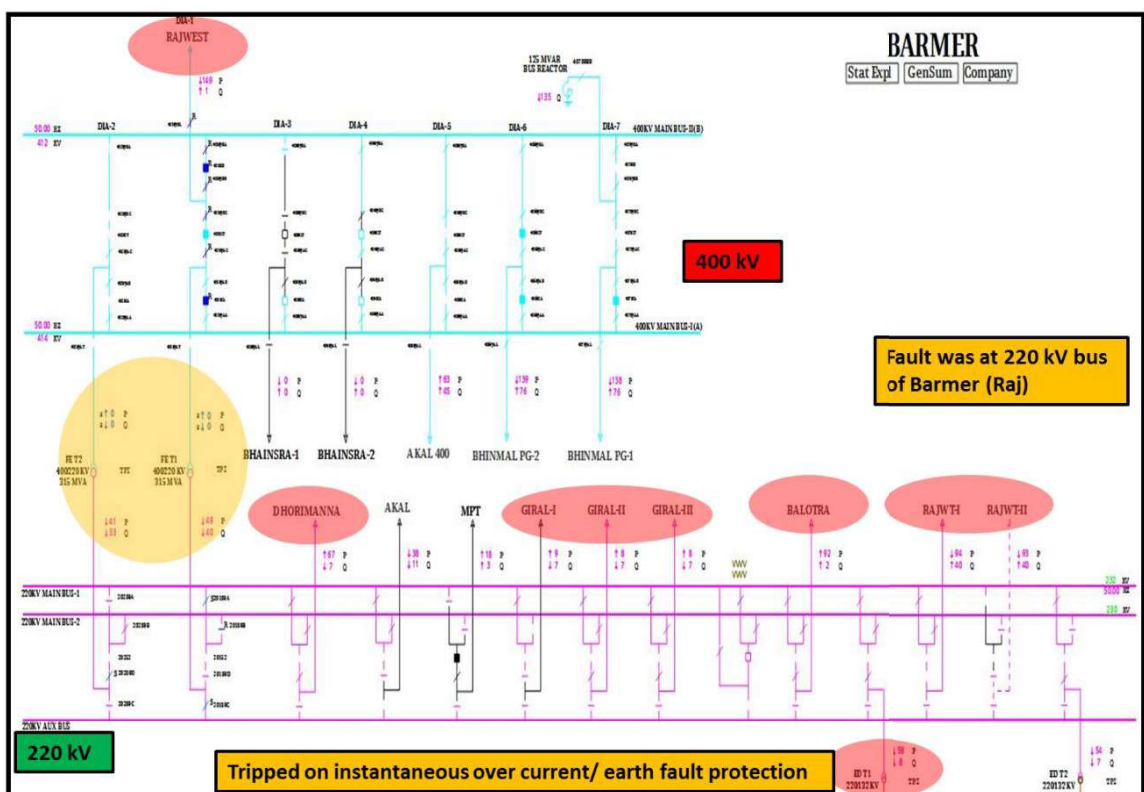
1. Single Line Diagram and Connectivity diagram of 400 kV Barmer (Raj):

2. 400/220 kV Barmer (Raj) station has one and half breaker scheme. It is connected through Rajwest S/C & Akal S/C. It also has two 315 MVA 400/220 kV ICTs.

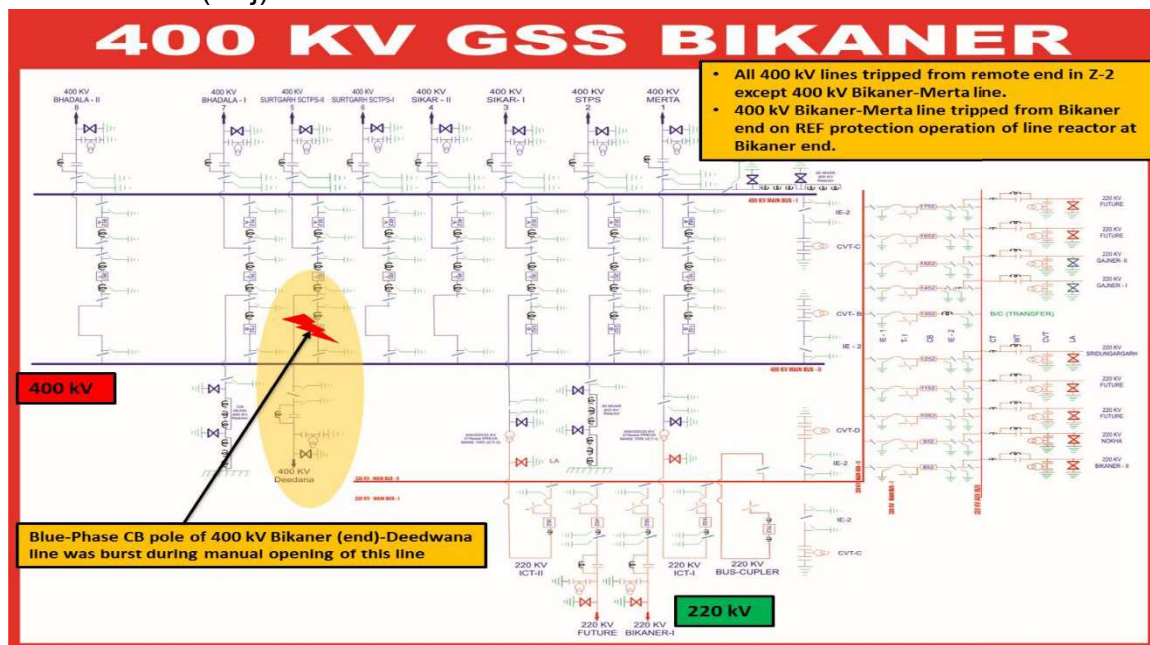
1. Single Line Diagram and Connectivity diagram of 400 kV Bikaner (Raj):

2. 400/220 kV Barmer (Raj) station has one and half breaker scheme. It is connected through Rajwest S/C & Akal S/C. It also has two 315 MVA 400/220 kV ICTs.
3. In antecedent conditions, 315MVA ICT 1 & 315MVA ICT 2 carrying 103 MW & 105 MW respectively. Manual opening of 400 kV Bikaner-Deedwana line on high voltage is under process.
4. At 17:45 Hrs, “Blue” phase CB pole of 400kV Bikaner (Raj)-Deedwana ckt failed during breaker opening on high voltage.
5. 400 kV bus bar protection was out of service due to fiber communication error.
6. 400kV BKN-STPS LINE, 400kV BKN-SCTPS LINE1&2, 400kV BKN-SIKAR LINE1&2, 400kV BKN-BHADLA LINE1&2 were tripped

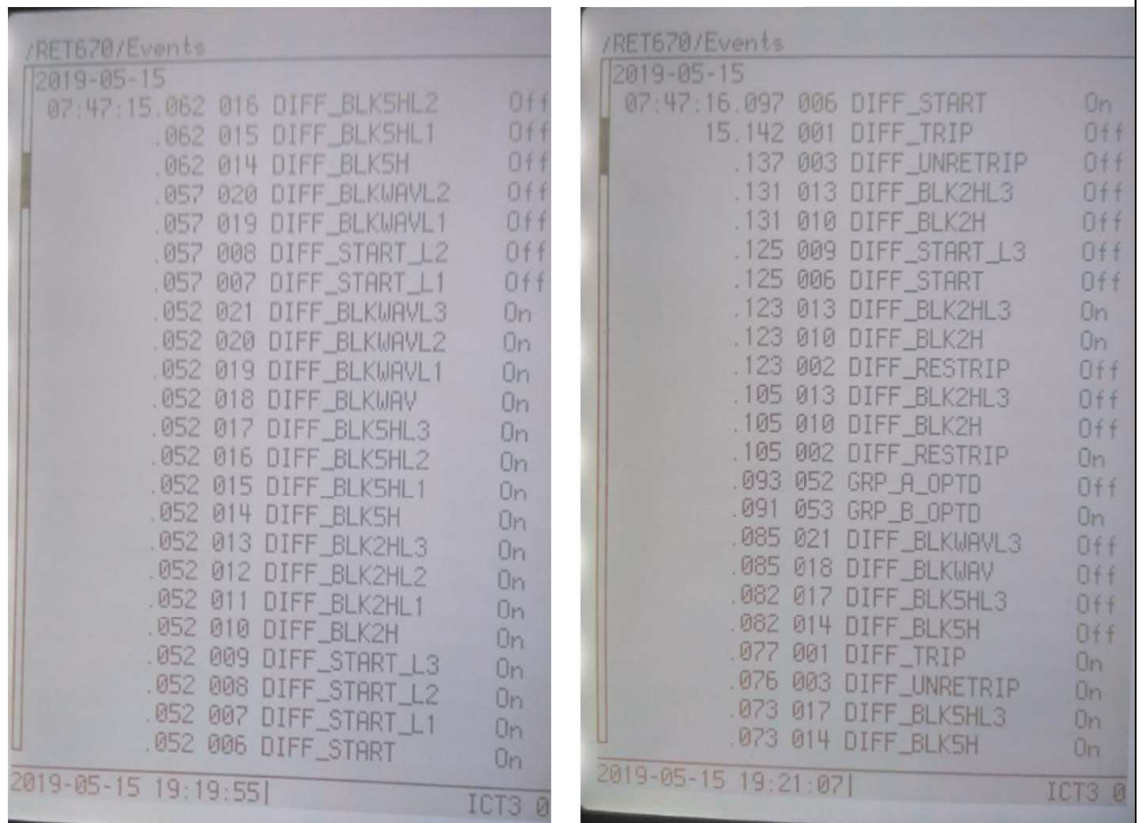
Differential protection operated. Time Sync error
