भारत सरकार  
Government of India  
विद्युत मंत्रालय  
Ministry of Power  
उत्तर क्षेत्रीय विद्युत समिति  
Northern Regional Power Committee

Subject: Minutes of 38<sup>th</sup> Protection Sub-Committee Meeting.

The 38<sup>th</sup> meeting of Protection Sub-Committee was held on **01.08.2019 and 02.08.2019 at 10:30 Hrs at NRPC Secretariat, New Delhi**. The minutes of the meeting for the meeting is available on NRPC website and same can be downloaded from <http://www.nrpc.gov.in> .

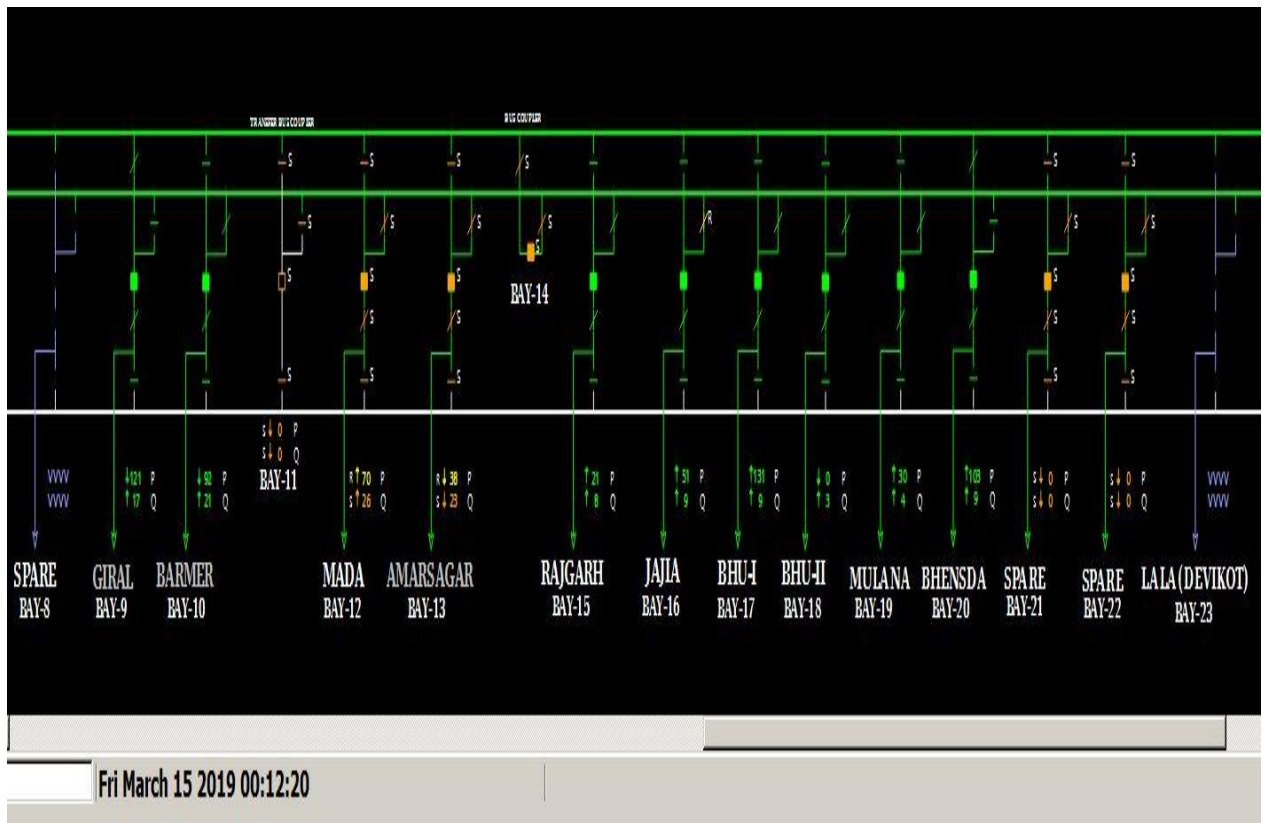
1. Single Line Diagram and Connectivity diagram of 400/220 kV Akal (Raj):

2. 400/220 kV Akal (Raj) station has one and half breaker scheme at 400 kV side. It is connected through Kankani D/C, Ramgarh D/C, Barmer S/C and Jodhpur S/C. It also has three 315 MVA 400/220 kV ICTs & one 500MVA 400/220 kV ICT.
