Subject: Revised Agenda for 36th Protection Sub-Committee Meeting.

36th Meeting of Protection Sub-committee of Northern Regional Power Committee

Date of meeting : 19th September, 2018

Venue : NRPC Secretariat, New Delhi

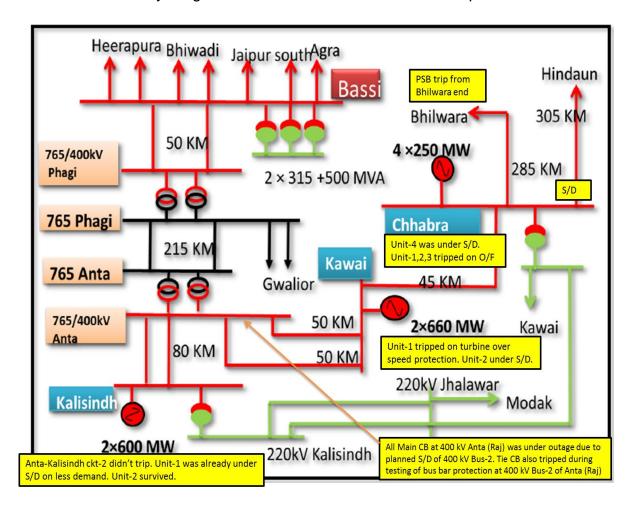
1. Connectivity Diagram of Chhabra/ Kawai/Kalisindh complex:

2. 400 kV Anta (Raj) is connected with Kawai D/C, Kalisindh D/C, Chhabra SCTPS D/C, Deedwana S/C and three 3*500MVA 765/400 kV ICT's. It has one and half breaker scheme.

- 3. 400 kV Bus-2 of Anta (Raj) was already under planned shutdown for testing of bus bar protection.
- 4. During testing all tie CB except tie CB for 400 kV Kalisindh ckt-2 tripped at 400 kV side of 765/400 kV Anta (Raj). No power system fault occurred in the system.

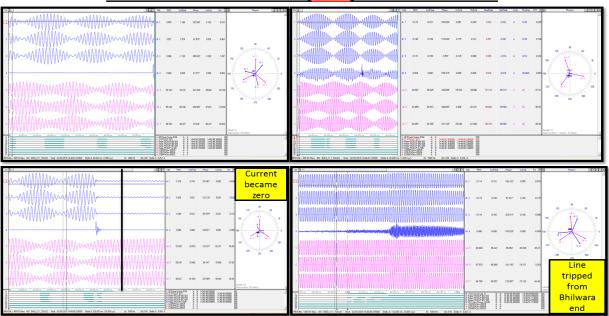
DR -400 kV Chhabra(end) -Bhilwara ckt

Continuous oscillation in observed in the line.
It seems DR capturing time is 1000ms instead of 2500ms (decided in PSC meeting)

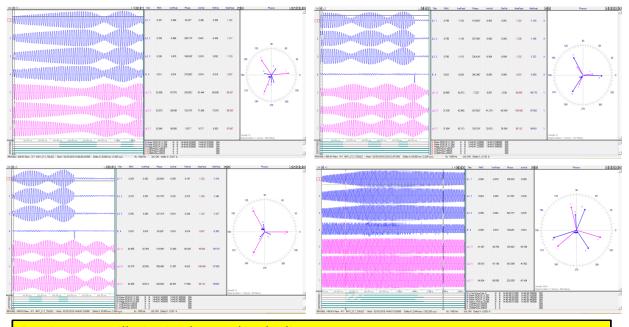
DR -400 kV Chhabra(end) -Kawai ckt

Continuous oscillation in observed in the line. It seems DR capturing time is less than 2500ms as decided in PSC meeting

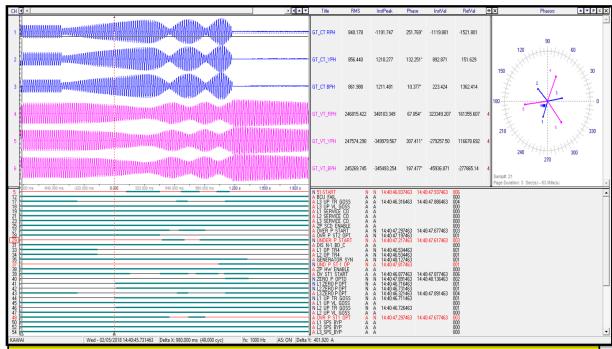
DR -400 kV Kawai(end) Unit-1

Continuous oscillation in observed in the line. Unit tripped on turbine over speed

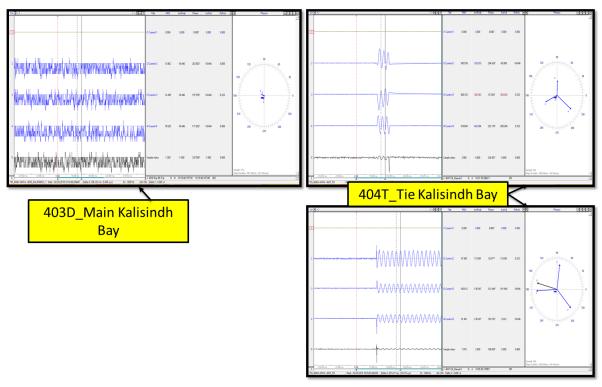
DR -400 kV Anta (end) Bus Bar

Time Synchronisation Error

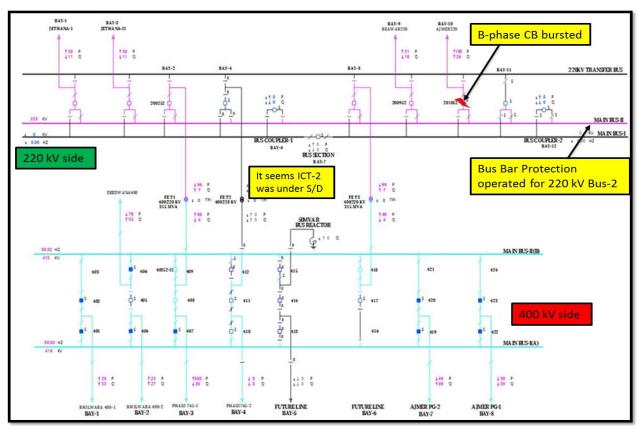
- c. B-phase CB of 220 kV Ajmer (400kV)-Ajmer (220kV) line was bursted at 400/220 kV Ajmer (Raj). It resulted into operation of bus bar protection for 220 kV Main Bus-II.
- d. Following element connected to 220kV bus-2 0f Ajmer (Raj) tripped:
 - 220 kV Ajmer-Jethana ckt-1 & 2
 - 220 kV Ajmer-Beawar ckt
 - 220 kV Ajmer-Ajmer(220kV) ckt
 - 400/220 kV 315MVA ICT-1 & 3 at Aimer (Raj)
 - 220 kV Bus Bar-II at 400/220 kV Ajmer (Raj)
- e. PMU plots of frequency, df/dt and phase voltage:

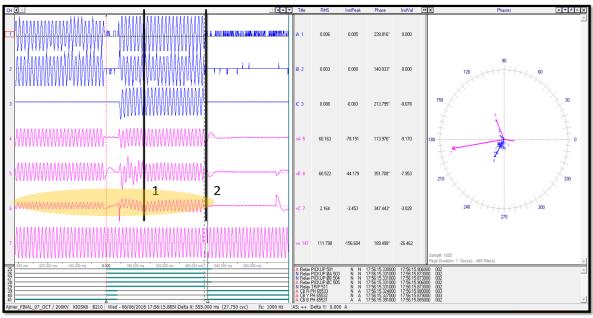
DR of 220 kV Ajmer4 (end)-Ajmer line

Point 1. Only B-phase was under open condition (from the start of the captured DR)

Point 2. All three phase of the line tripped

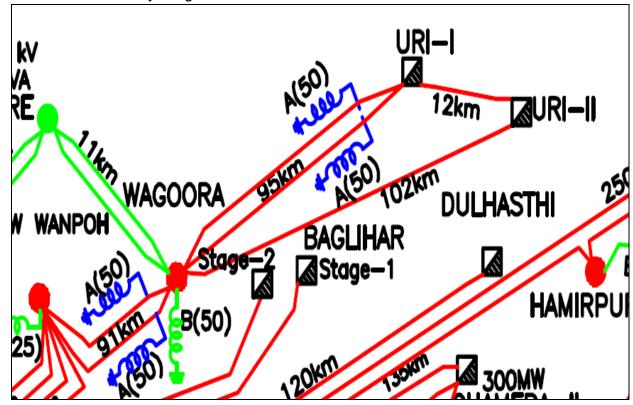
1. Connectivity Diagram:

- 2. R-N fault occurred in 400kV Uri-II-Uri-I ckt. R-phase opened at both ends.
- At the time of auto-reclosing, R-phase CB closed from Uri-I end but failed to close from Uri-II end resulting in tripping of other two poles on pole discrepancy.

- 4. At the time of opening of R-phase CB from Uri-I end, 400kV Uri-II-Wagoora ckt sensed fault in Z-1 from Uri-II end resulting in tripping of R-phase.
- 5. Units at Uri-II tripped at the time of opening of R-phase of both lines from Uri-II.
- 6. At Uri-I, in 400kV Uri-II-Uri-I ckt, R-phase fault occurred again after 245ms of closing of R-phase. Thus, 3-phase trip occurred due to fault in reclaim time. However, after 100ms, Y & B phases again got closed at Uri-I.
- 7. Name of the tripped elements are as below:
 - Unit #2, #3, #5 & #6 at Uri-II
 - 400kV Uri-II Uri-I
- 8. As per NHPC Report and DR details:

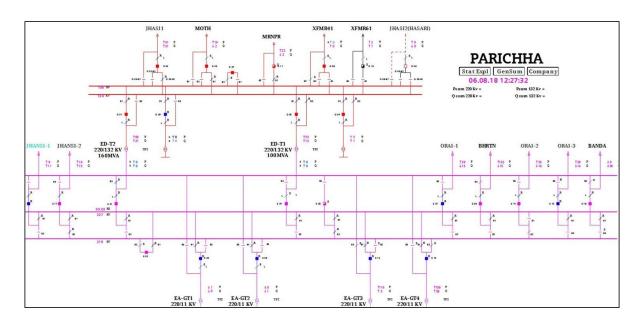
Single Line Diagram: Paricha TPS (220kV)

- Paricha TPS is having following elements at 220kV: Bhartna S/C, Orai T/C, Jhansi Dorana D/C, Mahoba S/C, 220/132kV 100MVA and 160MVA ICTs, 400/220kV 315MVA ICT #1 & #2. Paricha has 2x110+2x210+2x250MW generation capacity. It has DMT (double main transfer breaker) scheme.
- Antecedent condition:
 Unit #1 at Paricha TPS under planned S/D for R&M work since 02-Jul-16
- 4. B-phase CT of 220kV bus-A of bus coupler get damaged.
- 5. This resulted in complete outage of Paricha TPS.
- 6. Name of the tripped elements are as below:
 - Unit #2, #3, #5 & #6
 - 220kV Paricha-Orai-1, 2&3
 - 220kV Paricha-Mahoba
 - 220kV Paricha-Jhansi Dorana D/C
 - 220kV Paricha-Bharthna
 - 220/132kV 100MVA & 160MVA ICTs
 - 400/220kV 315MVA ICT #1 & #2
- 7. As per UP Report:

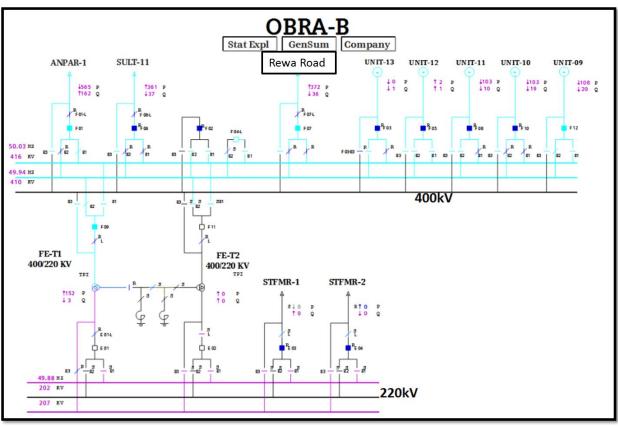
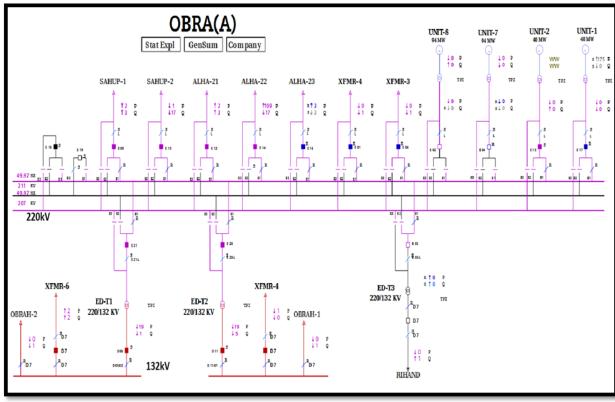
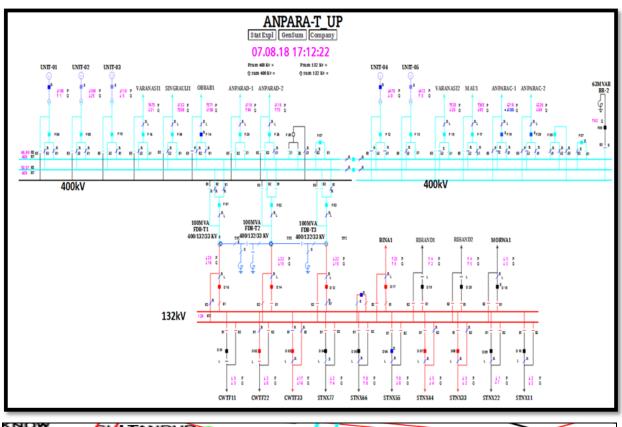
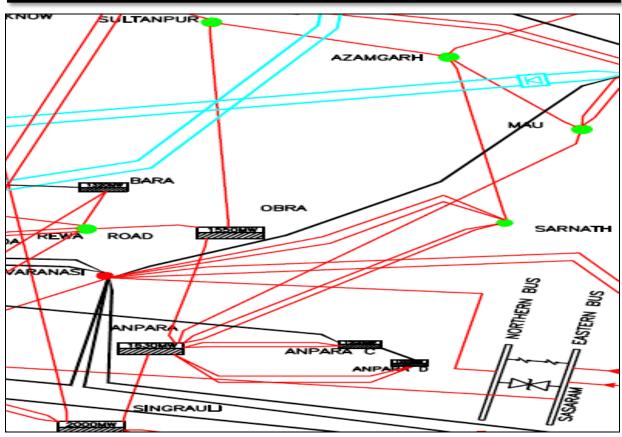
1. Single Line Diagram of Obra-A, B TPS and Anpara-A TPS:

- 2. 400 kV Obra-B TPS is connected with Anpara TPS S/C, Rewa Road S/C and Sultanpur S/C. It also has five units of 200MW and two 400/220kV 240MVA ICTs. It has DMT bus bar scheme.

- 3. On 28th May 2018 at 21:28hrs 400 kV Anpara-Obra line tripped on R-phase to earth fault. All three phase of the line tripped from Anpara end however Y&B-phase stucked at Obra end.

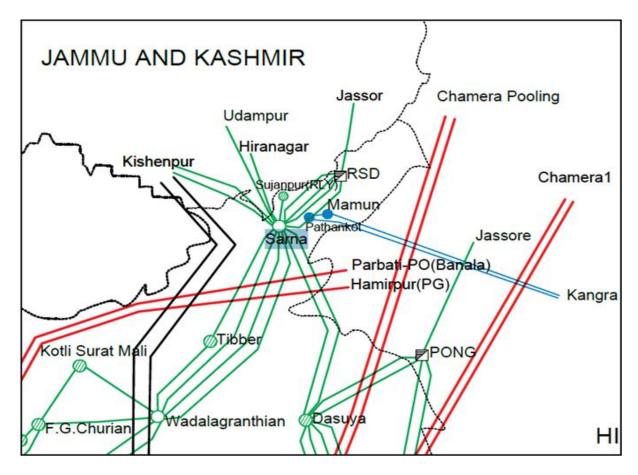
- 2. 220 kV Sarna HEP connected with Wadala Granthian four ckt (one ckt LILOed at Tibber), RSD (Ranjit Sagar Dam) four ckt, Kishenpur D/C, Dasuya D/C, Sujanpur Railway D/C, Hiranagar S/C, Udhampur S/C, one ICT of 220/132kV & one ICT of 220/66kV.
- 3. Bus scheme is double bus single breaker scheme at 220kV Sarna stations.
- 4. In antecedent condition:
 - As per SCADA data, it seems 220 kV Bus-2 of Sarna (Punjab) was already under outage
 - 220 kV Sarna-Wadala granthian ckt-1 & 2, 220 kV Sarna-RSD ckt-3 & 4 was also under outage
- 5. CT (Current Transformer) of 220 kV Sarna (end)-Wadala granthian ckt-4 bursted and resulted into bus fault for 220 kV Sarna (Punjab).
- 6. Name of the tripped elements:
 - 220 kV Kishenpur-Sarna ckt-1 &2
 - 220 kV Sarna-Wadala ckt-IV
 - 220 kV Sarna-Timber ckt
 - 220 kV Sarna-Dasuya ckt
 - 220 kV Sarna-Hiranagar (J&K) ckt

- 220 kV Sarna-Udhampur ckt
- 220 kV Sarna-RSD ckt-1 & 2

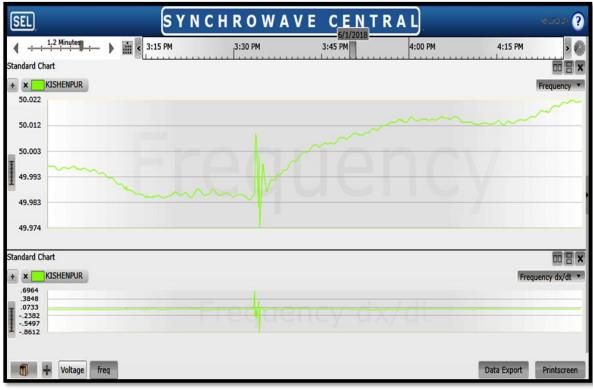
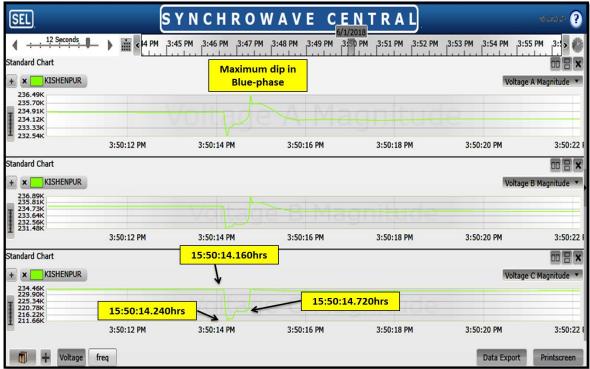
7. PMU plot of frequency, df/dt and phase voltages:

- 8. As per PMU and SCADA data:
 - B-N fault observed at 15:50:14.160hrs
 - Voltage dip observed in Blue phase.
 - Fault clearance time 580ms.
 - SCADA MW flows:

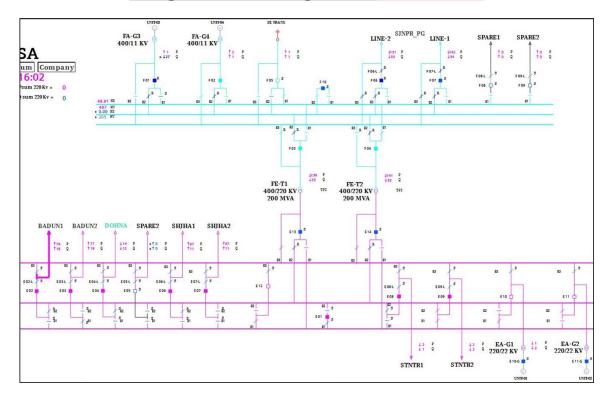
Single Line Diagram: Rosa TPS

- 2. Rosa TPS has following elements at 220kV: Badaun D/C, Shahjahanpur(UP) D/C, Dohana S/C, Unit #1, #2; At 400kV: 400kV Shahjahanpur(PG) D/C and Unit #3, #4; Rosa TPS has 4x300MW capacity.
- 3. Antecedent condition and tripped elements as per UP report:

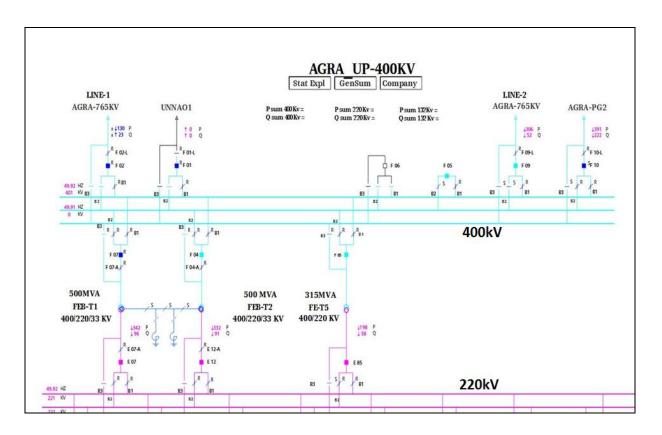
1. Single Line Diagram of 400 kV Agra (UP):

- 2. 400 kV Agra (UP) is connected with Fatehabad (UP) D/C, Agra (PG) S/C and Unnao S/C. It also have three 400/220 kV ICTs (2*500MVA+1*315MVA).
- 3. 400 kV Agra (UP) has double main and transfer scheme.
- 4. 400kV Agra(UP)-Unnao(UP) under planned S/D from 29-Apr-18 to 22-Jun-18 for Diversion of line (Tower no 591 596) due to Firozabad bypass Road of NHAI.
- 5. As reported, bus bar protection mal-operated at 400kV Agra (UP). All 400kV connected elements tripped.
- 6. Tripped elements:
 - 400kV Agra(UP)-Fatehabad(UP) D/C
 - 400kV Agra(UP)-Agra(PG)
 - 400kV/220kV 500MVA ICT #1, #2 at Agra(UP)
 - 400kV/220kV 315MVA ICT #3 at Agra(UP)

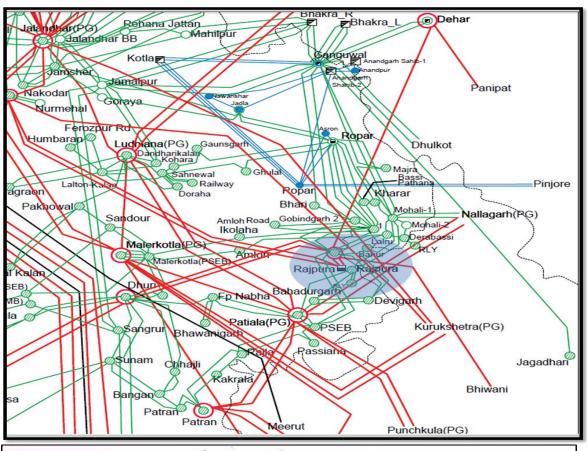
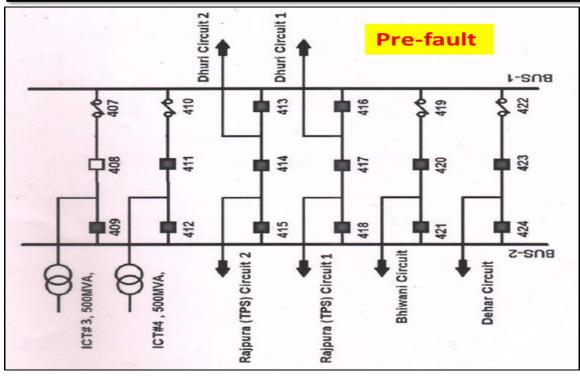
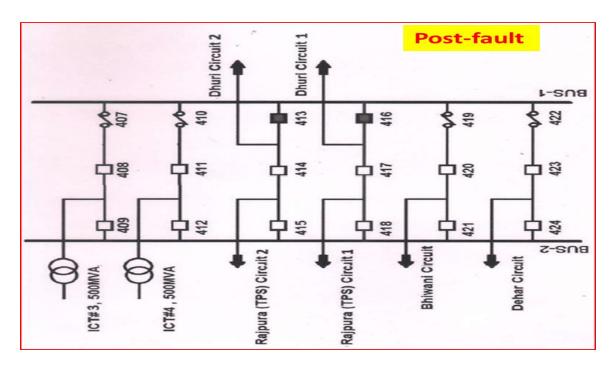
10. Connectivity Diagram:

- 11. At Rajpura (PSTCL), optical cable wire broke and fell on 400kV bus-2 at 400/220 kV Rajpura (PSTCL).
- 12. This resulted in operation of bus bar protection for 400 kV bus-2 and all CBs connected to 400 kV Rajpura (PSTCL) bus-2 tripped.
- 13. At the same time, tie CBs of feeders also tripped mainly due to wrong mapping of function in relay. The same has been reportedly corrected.
- 14. In antecedent condition:
 - Tie CB of 400/220kV ICT #3 already open (Dia not completed as future bay.
- 15. Name of the tripped elements:
 - Unit 1 and 2 at Rajpura Thermal
 - 400kV Rajpura-Rajpura Thermal D/C
 - 400kV Rajpura-Bhiwani
 - 400kV Rajpura-Dehar
 - 500MVA ICT 3&4 at Rajpura
- 16. PMU plot of frequency, df/dt and phase voltages:

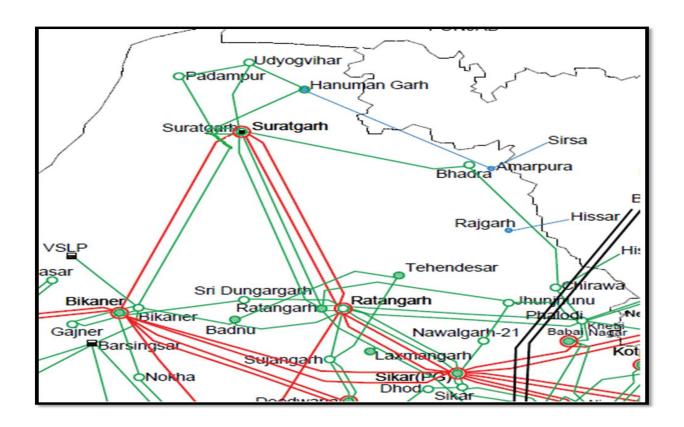
22. Connectivity Diagram of 400/220 kV Suratgarh TPS:

- 23.220 kV Suratgarh TPS is connected with Ratangarh D/C, Suratgarh(Raj) D/C, Sriganganagar S/C and Bhadra S/C. It also have two 400/220kV ICTs (2*315MVA). Unit-1&2 (250MW) connected at 220 kV station and Unit-3,4,5&6 (250MW) connected at 400 kV Suratgarh TPS. 400kV Suratgarh TPS is further connected with Ratangarh S/C, Bikaner S/C, Suratgarh SCTPS D/C.
- 24.400 kV Suratgarh TPS has one an half breaker scheme and 220 kV Suratgarh TPS has DMT (double main transfer breaker) scheme.

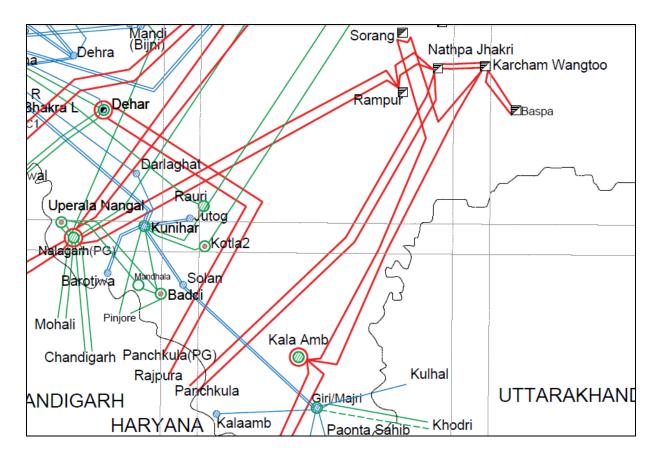
13. Connectivity Diagram:

- 14.400 kV Rampur is connected with Jhakri D/C, Nalagarh D/C. 400 kV Rampur have six unit of 68.67 MW capacity. 400 kV Jhakri is connected with Rampur D/C, Panchkula D/C and Karcham D/C. 400 kV Jhakri have six unit of 250 MW and 400 kV Karcham have four units of 250MW.

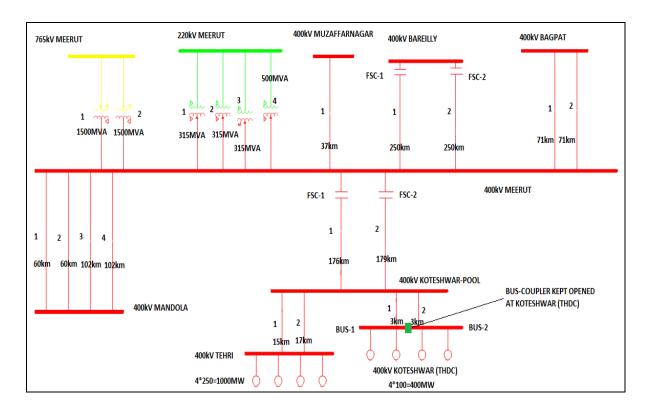
Tehri HEP is the major hydro generating station with 1000MW (4*250MW) capacity and in its downtail Koteshwar (THDC) HEP with capacity of 400MW (4* 100MW). The main evacuation line from the Tehri-Koteshwar HEP complex is 176 kM long 400 kV Koteshwar Pool to Meerut D/C line with 50% series compensation of each circuit at Meerut end. Connectivity Diagram is as below:

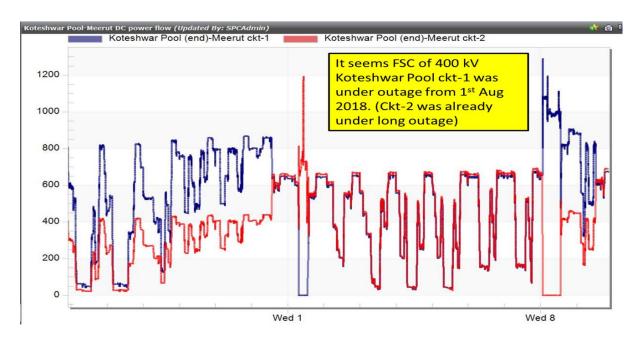
Fixed Series Compensation (FSC) of 400 kV Koteshwar Pool- Meerut- ckt-2 is out of service since 16th July 2015 except for brief period during July 2017 (01-13 Jul 2017). FSC of 400kV Koteshwar Pool -Meerut ckt-1 also went under outage on 1st Aug 2018. Thus at the incident time both the FSCs were out of service. SCADA plot of power flow of 400 kV Koteshwar Pool-Meerut ckt-1 & 2 is as below:

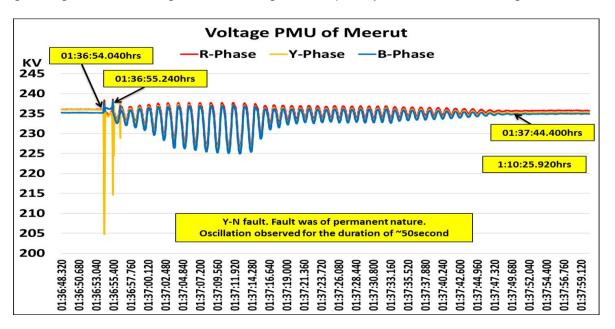
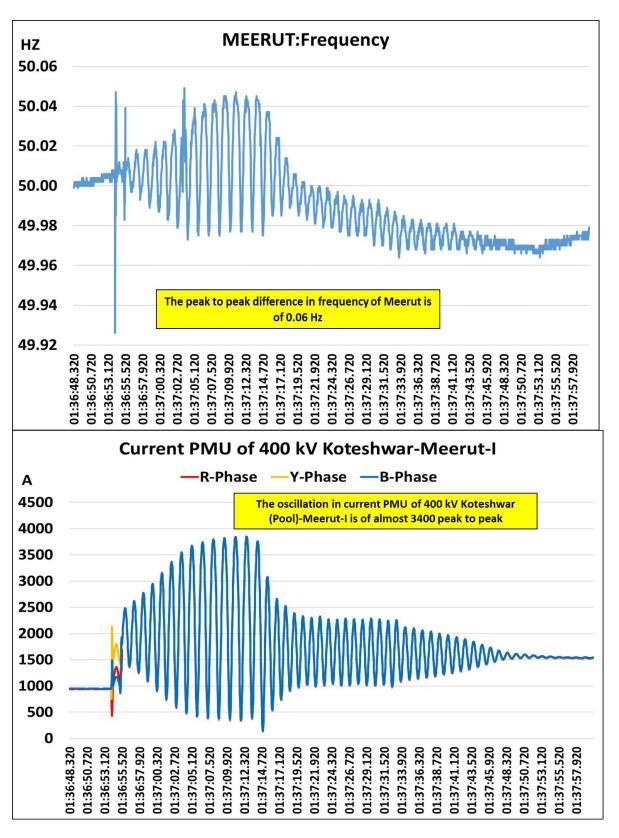
The outage of 400 kV Tehri-Koteshwar (Pool) ckt-2 caused severe oscillations of growing nature in the grid. The voltage & Frequency of Meerut PMU is given below:

The oscillations seems to damp only after tripping of one unit at Tehri HEP after 21 second on some protection.

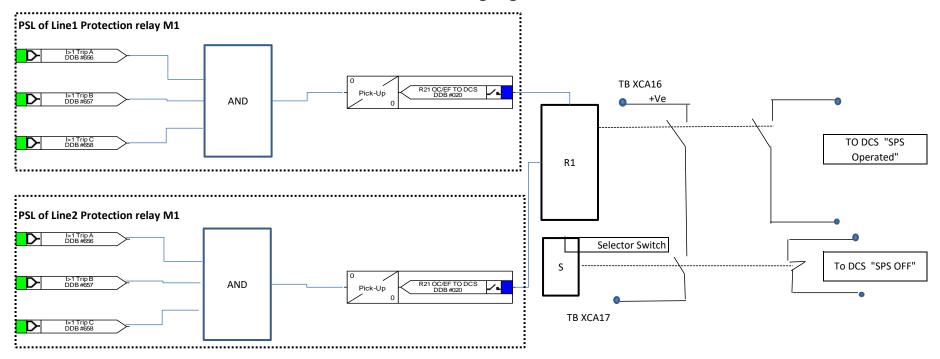
SPS scheme for Dhauliganga Power Station

R1- 220 V DC pickup relay (to be installed)
