Ministry of Power

Northern Regional Power Committee

Subject: Minutes of 40<sup>th</sup> Protection Sub-Committee Meeting.

The 40<sup>th</sup> meeting of Protection Sub-Committee was held on **02.03.2020** at **10:00 hrs** at **NRPC Secretariat, New Delhi**. The minutes of the aforesaid meeting are available on NRPC website and same can be downloaded from <https://www.nrpc.gov.in>.

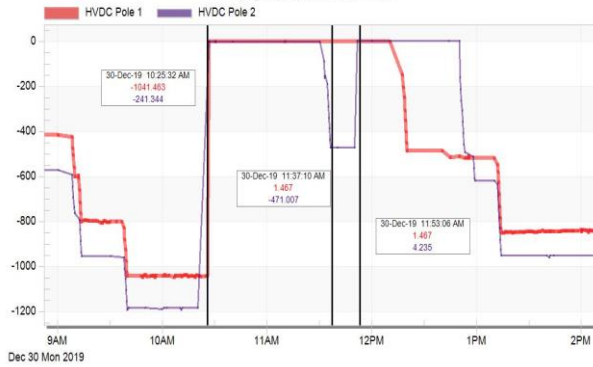
**Champa-Kurukshetra HVDC Flowpattern during tripping**

- There was no abnormality in the system but due to improper reflection of Pole-3 current for common area, Pole-1 & 2 was blocked. Further, as per scheme there is intercommunication between Bipole-1 (Pole-1 & 2) and BiPole-2 (Pole-3 right now) for the said pole-1 but there was no feedback from Bipole-2, hence all pole-3 also got tripped.

- **Special finding/ issues identified during restoration:** There is some bits communication issue between Bipole-1 and Bipole-2, which is the cause of such mal operations.

| S. No. | Name of the Element (along with voltage level) | Corrective Action Implemented | | Corrective Action Recommended | | Time frame for pending Recommendation | | Remarks |
|---|---|---|---|---|---|---|---|---|
| 1 | 800 kV HVDC Pole-1, 2, & 3 | The cause of maloperation i.e. intercommunication problem or any bug issue has been taken up with OEM. OEM ensured to rectify it during coming shut down for Pole-4 under commissioning. | | | | | | |

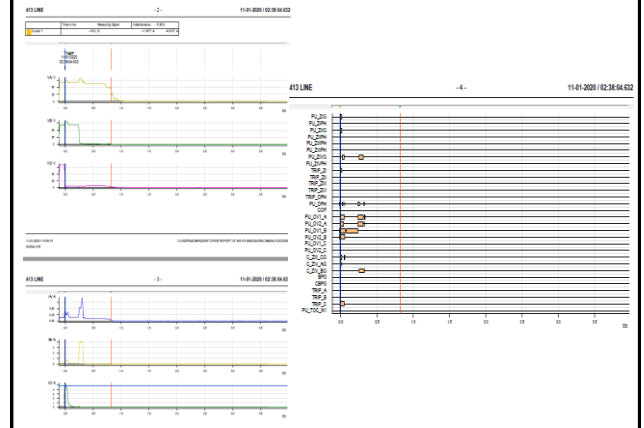
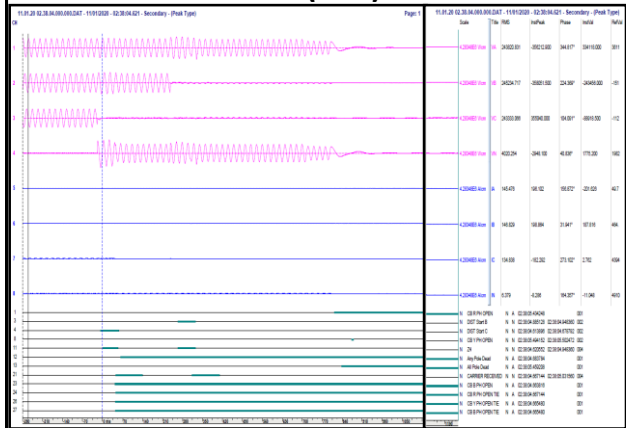
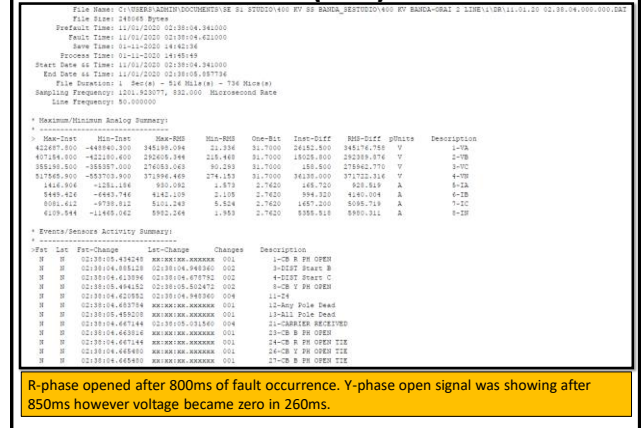
## 400 kV Banda (end)- Orai ckt-2

- On 11.01.2020 at 02:38Hrs. B-phase CT of Tie Bay of 400KV Banda – Oraia-II blasted at 400KV Banda S/S.
- Since 400KV Banda S/S is connected to 400KV Rewa Road S/S through double circuit line in which circuit -II was already open due to high voltage and ckt-I at 400KV S/S Rewa Road sensed the fault in Z-2 with above mentioned flag.
- At 400KV S/S Rewa Road due to pole discrepancy in the CB of 400KV Rewa Road-Banda line- I, K-phase, Y-phase pole opened but B-phase pole opened with some time delay so the line did not trip timely which caused LBB to operate.
- At that moment all the elements was connected to same bus so all the element at 400KV side tripped except 400KV Rewa Road – Meja line.
- As per information received, protection cable of relay of 400KV Rewa Road – Meja line was loose so that no tripping command was given to 400KV Rewa Road – Meja line.

- In antecedent condition, 400kV Banda-Orai ckt-1 opened on High voltage & 400kV Banda-Rewa Road ckt-2 opened on High Voltage.
- Y-phase CT of tie bay of 400 kV Banda-Orai ckt-2 bursted and finally tripped but at the same time 400 kV Banda-Rewa Road (end)- ckt-1 also sensed the fault in Z-1 and issued tripping command for B-phase breaker. B-phase breaker failed to operate and further resulted into LBB (Local breaker backup) protection operation.

- 400 kV Breaker in which pole discrepancy was found, has been tested and found ok.
- Protection cable of relay of 400 kV Meja-Rewa Road line has been inspected and corrective action had been taken on 11.01.2020
- Concerned officer may give reason for connecting all the elements in 400 kV Bus-1 at Rewa Road (UP)
- Concerned authority may carry out thorough testing of breakers and relays

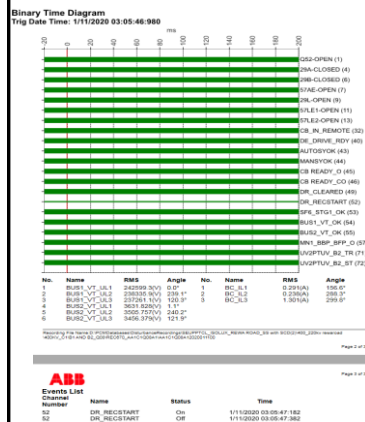
## DR of 400 kV Rewa Road (end) Bus Bar

- 125MVar Bus Reactor 2:38:04:919 hrs on 11.01.2020
- 400KV Rewa road-Panki line 2:38:04:922 on 11.01.2020
- 400KV Rewa road-Masauli line 2:38:04:922 on 11.01.2020
- 315MVA ICT#1 2:38:04:922 on 11.01.2020
- 315MVA ICT#2 2:38:04:922 on 11.01.2020
- 400KV Rewa road-Obra line 2:38:04:925 on 11.01.2020
- 400KV Rewa road-Banda ckt#1 i line 2:38:06:836 on 11.01.2020 (**Breaker failed to operate, LBB protection operated**)

- LBB protection operation resulted into operation of 400 kV bus bar protection for 400 kV bus-1 at Rewa Road. All the elements at 400 kV Rewa Road (UP) station were connected on 400 kV Bus-1 and all the elements tripped due to LBB operation except 400 kV Rewa Road-Meja ckt, it didn't trip due to loose protection control cable.

- 400 kV Breaker in which pole discrepancy was found, has been tested and found ok.
- Protection cable of relay of 400 kV Meja-Rewa Road (end) line has been inspected and corrective action had been taken on 11.01.2020
- Concerned officer may give status of tie bay CT replacement in 400 kV Banda (end)-Orai ckt-2
- Concerned officer may give reason for connecting all the elements in 400 kV Bus-1 at Rewa Road (UP)
- Concerned authority may carry out thorough testing of breakers and relays

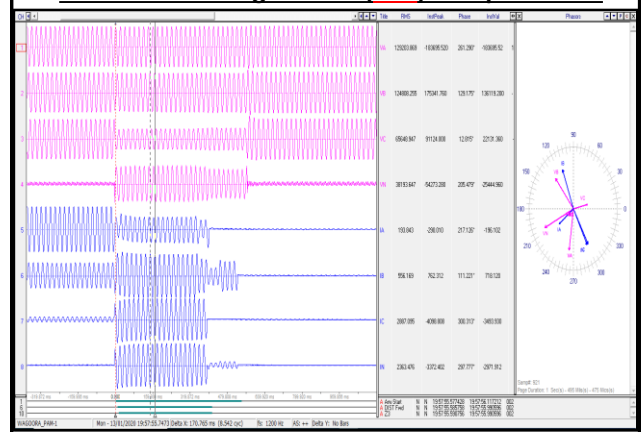
**DR of 220 kV Wagoora PG (end)-Pampore ckt-1**

**A. Event Description / Analysis of the Event:** Both Lines tripped on B-N fault in Zone-3. The fault location observed at Waggaora is 47.5 km and 42.5 km for ckt-1 and 2 respectively. However, the total line is 30.29 km only. Fault lies in the 220 kV or 132 kV level of JKSPCL (JKPDD). It is also learnt that bus Voltage at 220 kV Pampore substation became zero.

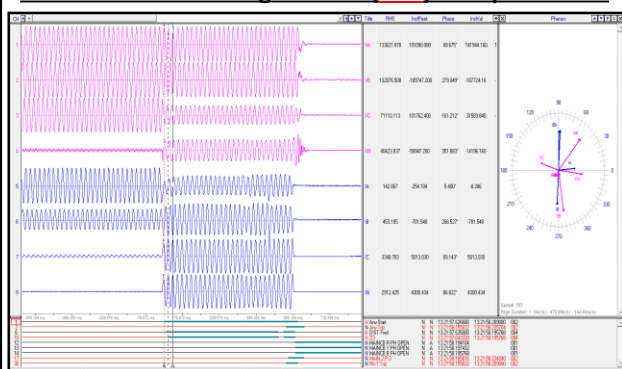
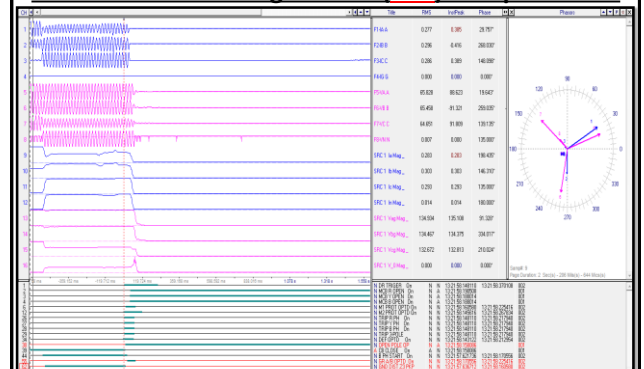
**M1 DR of 220 kV Wagoora PG (end)-Pampore ckt-2**

**M2 DR of 220 kV Wagoora PG (end)-Pampore ckt-2**

M-2 operated on DEF (directional earth fault protection). Sensitive DEF setting needs to be looked into.

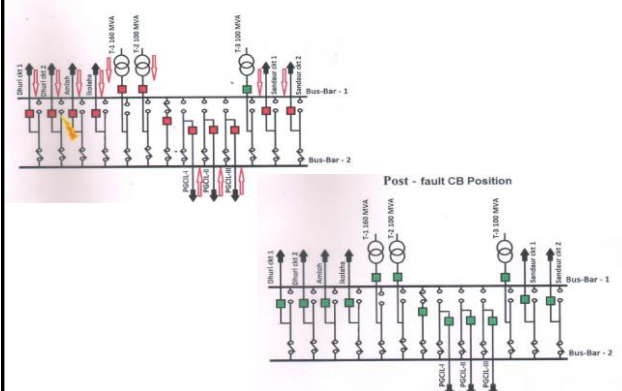
#### At fault CB Position

| e. Description and cause of event. | R-phase Insulator string (between CB and Bus isolator) of Dhuri Ckt-2 (Connected to Busbar-1) snapped and jumper fell on Busbar-2 leading to Bus Fault on both Bus-bars. |

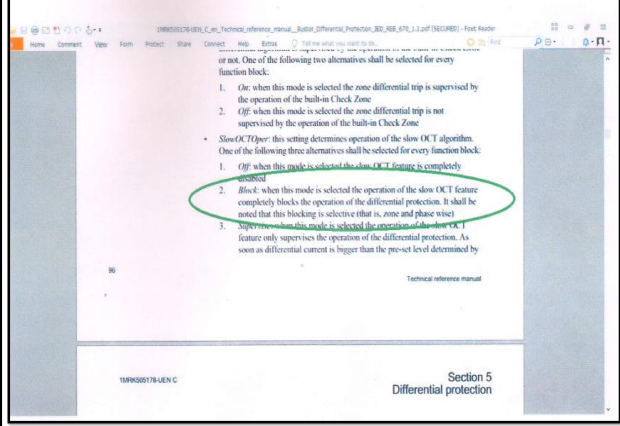
## DR of bus bar protection at Malerkotla Punjab

| 4. Reason of delayed clearance of fault as per IEGC. | Bus bar relay was in blocked condition |

- In future cleaning/ strengthening of insulators with silicon RTV coating etc. has been suggested to O&M staff.
- To make isolator auxiliary switches healthy to avoid human error.
- Settings changed from "BLOCK" to SUPERVISE so that whenever Id crosses threshold value the scheme will operate irrespective of BLOCK.
- To educate the operating staff regarding intimating to S/S incharge

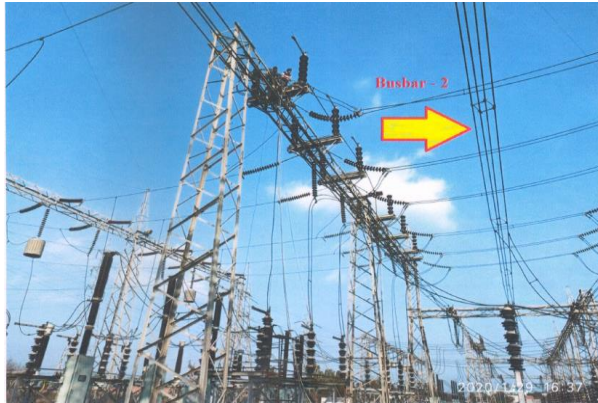
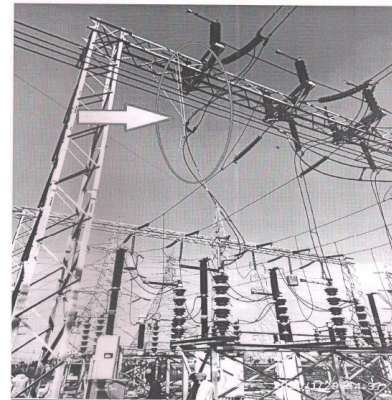
## As per Punjab details (Fault location)

- ❖ 220 kV Malerkotla – Dhuri Circuit – 1
  - Distance Protection Relay picked the fault in R-ph in Zone – 4 (Reverse Zone).
  - Fault cleared from remote end in around 350 msec.
- ❖ 220 kV Malerkotla – Ikolaha
  - Distance Protection Relay picked the fault in R-ph in Zone – 4 (Reverse Zone).
  - Fault cleared from remote end in around 400 msec.
- ❖ 220 kV Malerkotla – Sandaurh Circuit – 1
  - Fault cleared from remote end in zone 2.
- ❖ 220 kV Malerkotla – Sandaurh Circuit – 2
  - Distance Protection Relay picked the fault in R-ph in Zone – 4 (Reverse Zone).
  - Fault cleared from remote end in around 360 msec.
- ❖ 220 kV Malerkotla – Amloh
  - Fault cleared from remote end in zone 2.
- ❖ All other circuits also tripped from remote ends leading to complete blackout at 220 kV Substation Malerkotla.

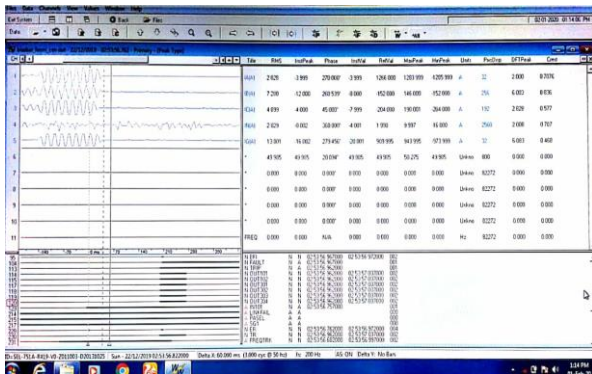
## HV side L.B.B. Relay DR of ICT1 at 400kV s/s Sult

- **Cause of Event**
- Delayed tripping of 2200kV Sultanpur-Pratapgarh Line C.B. (Bus Transfer) at Sultanpur end for Rph fault.
- After thorough investigation of trip logic & DR of S.E.L. make L.B.B. relay (type SEL-487) installed on HV side of ICT1 it was found that even after isolation of fault leading to negligible phase current 'SV05' bit in trip logic of the relay remained high leading to spurious operation of LBB relay and hence tripping of all elementd connected to 400kV Bus A.
- **Action Taken**
- The CB timing of 220 kV BT , 400/220 kV side C.B. of ICT1 measured
- 220kV Pratapgarh Line DPR & ICT1 LBB relay tested.
- High set setting of 400/220kV ICT 1 & 3 modified.
- Matter regarding configuration logic of LBB relay referred to Design/S.E.L.
- **Action to be taken**
- Configuration logic to be modified in all S.E.L. make LBB relay.

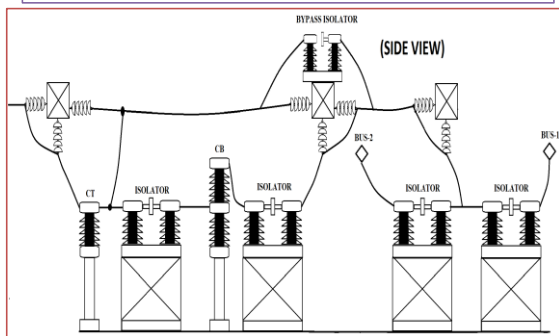
## General Layout of affected Bay (220 kV Malerkotla – Dhuri Ckt -2)

- R-phase insulator string (Before CB, i.e. Bus side) of 220 kV Malerkotla – Dhuri circuit No. 2 snapped.
- Weather conditions : Heavy rain & winds
- Jumpers fell on Busbar-2 leading to Bus-bar fault.

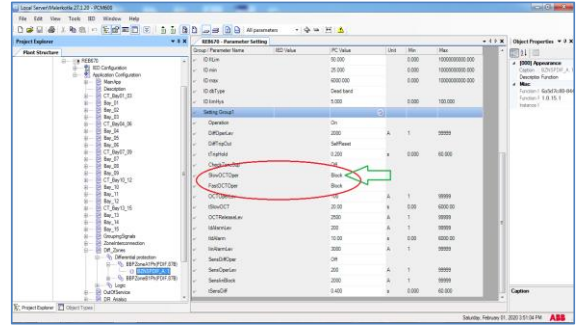
## Settings which blocked the relay

- The fault current ( $I_d$ ) entered in bus-2 differential zone (Zb) of the R-ph BBPS Relay (ABB make REB 670).
- No TRIP was issued by the bus bar differential protection relay.
- Za & Zb SLOW OCT (Open CT) Alarm was found to be already raised before fault event (which had blocked the differential protection feature of the relay).

- Since bus-bar differential protection feature of BBPS Relay was in blocked state, it failed to clear the bus-bar fault.
- Fault was in reverse zone of the connected circuits, so their Distance Protection Relays got picked in Z4.
- Fault feeding continued until the connected circuits tripped from remote end (Zone-2 at their ends).

- Healthiness of 220 kV bus bar protection at 220 kV Malerkotla (Punjab) shall be ensured.
- Healthiness of isolator auxiliary contact shall be checked and corrected as manual operation every times may have resulted into frequent blocking of bus bar protection. If it needs replacement than same shall be done.

- Bus Bar Protection blocking alarm needs to be prioritized and attended immediately.
- Backup over current earth fault protection setting of 400/220 kV ICTs needs to be relooked. Present Status of replacement of backup over current earth fault protection at 400/220 kV 315 MVA ICTs at Malerkotla (PG)?

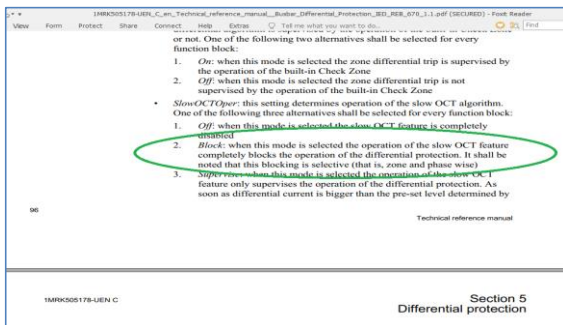
## Literature of the relay (BLOCKING the differential protection feature)

- Unavailability of Healthy Isolator status from switch yard (due to old/outdated isolators)
- A scheme of two way electrical switches (two for each bay (bus-1 & bus-2)) is devised to manually simulate the similar isolator status to the relay as per actual arrangement in the switchyard
- Any mismatch or performing wrong sequence of switch operation leads to raising of OCT Alarm which is the in-built feature of this relay model.
