Subject: Agenda for 37th Protection Sub-Committee Meeting.

Agenda for
37th Meeting of Protection Sub-committee of Northern Regional Power Committee

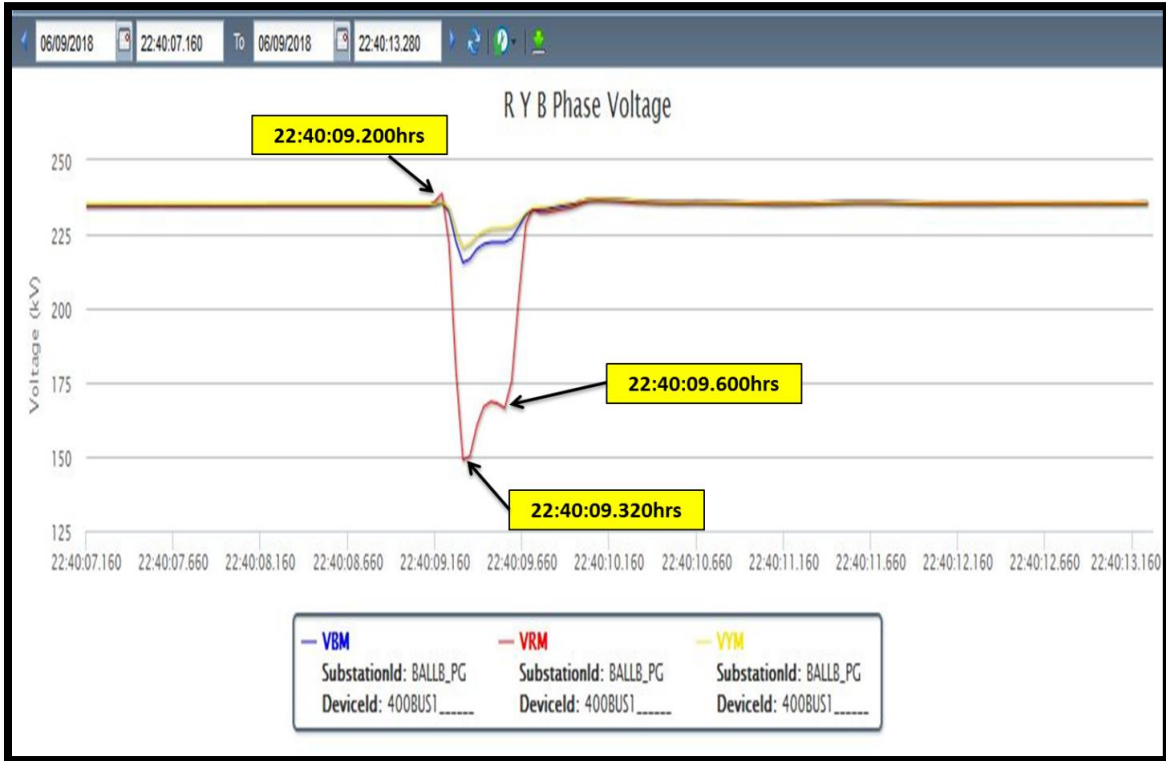
As per PMU data maximum dip in R-phase and fault clearance time was ~400ms. Delayed clearance of fault as per PMU data. PMU plot of phase voltages of Ballabhgarh (PG) is as below:

AS per PMU plot of frequency, it seems load loss occurred in the system.

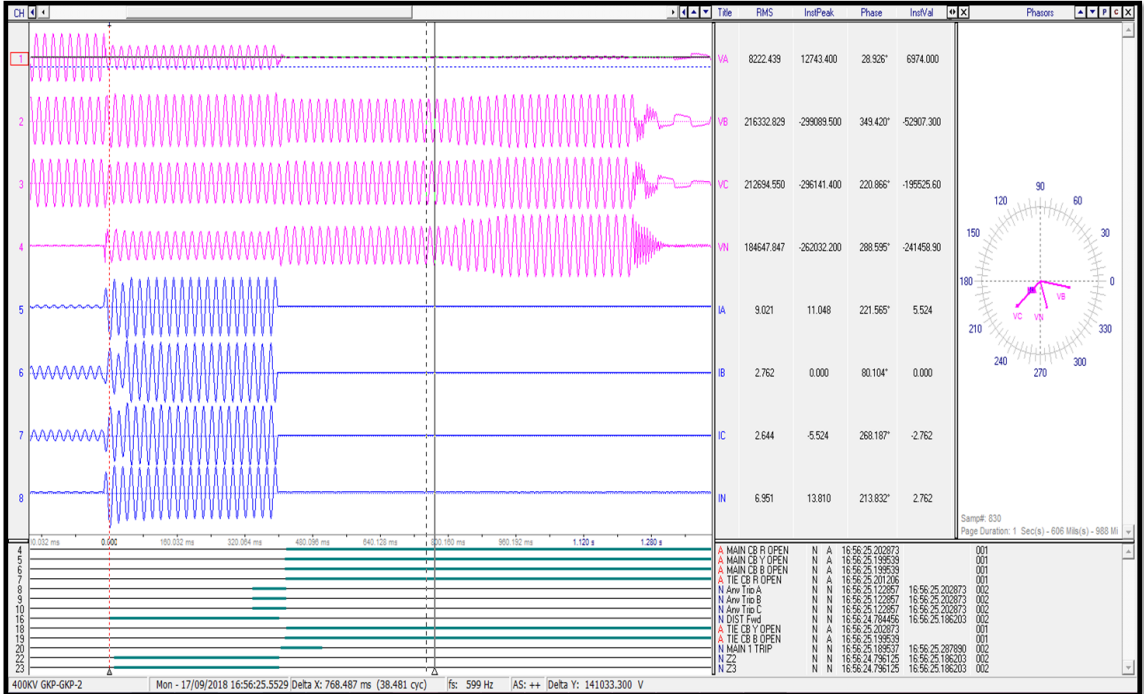
DR details of 400 kV Gorakhpur PG(end)-Gorakhpur UP ckt-2

It seems line tripped from PG end in Z-2. Gorakhpur (UP) end connected for another 800ms as voltage persisted for that period.

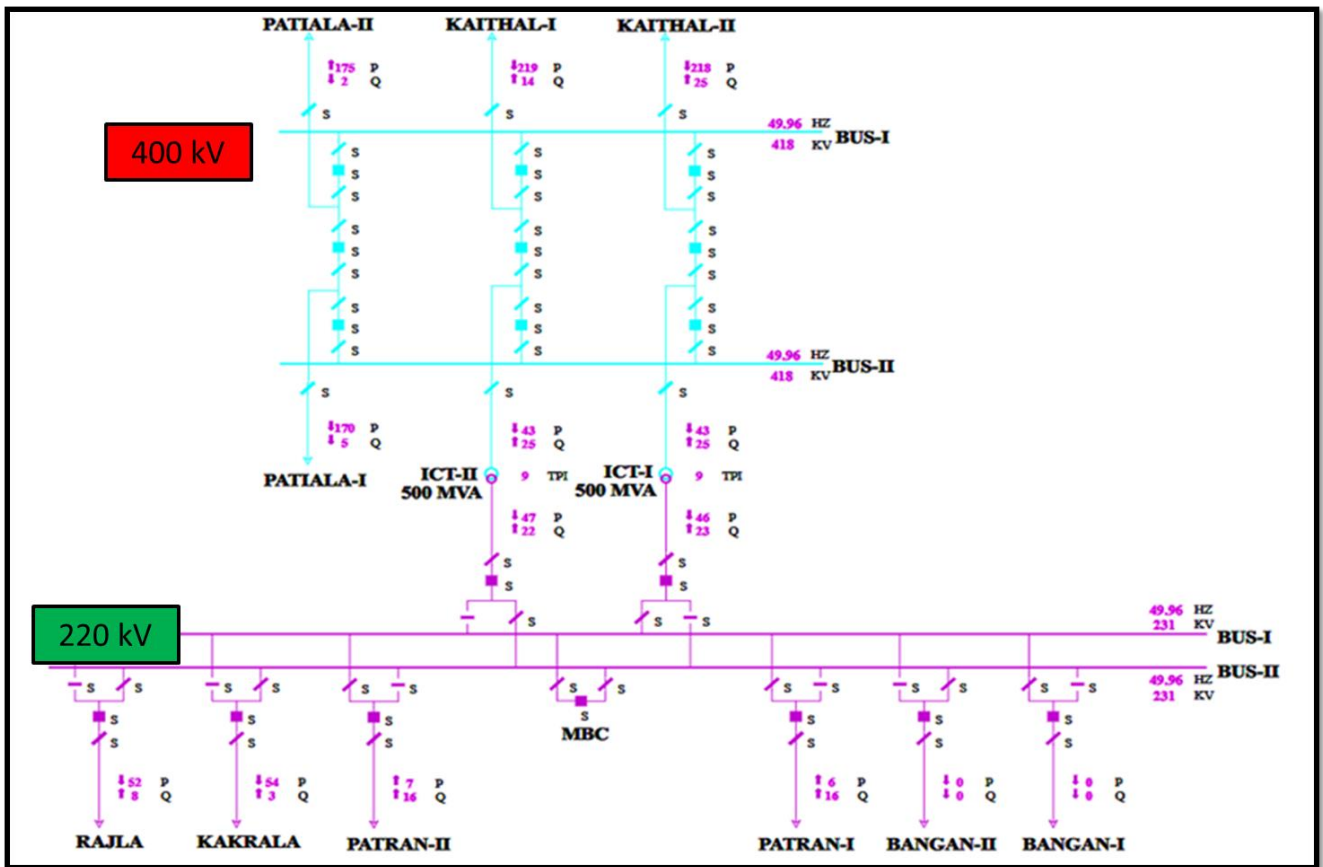
1. Connectivity Diagram of 400/220 KV Patran substation:

2. 400 kV Patran s/s is connected with 400 KV Patiala D/C, 400 KV Kaithal D/C and has two 500MVA 400/220 kV ICT's. It has one and half breaker scheme at 400 kV level and DM (double main) scheme at 220 kV level.
3. At 11:11:57 all 400 lines and both 500 MVA ICTs at 400/220 kV Patran station tripped.
4. The DR and event loggers are showing DC supply fail signal only with no tripping signal issued.
5. Antecedent Condition:
 - 400 kV Patran-Kaithal ckts were carrying 139 MW each.
 - 400 kV Patran-Patiala ckts were carrying 68 MW each.
6. Name of the tripped elements are as below:
 - 400 kV Patran - Kaithal ckt-1 & 2
 - 400 kV Patran - Patiala ckt-1 & 2
 - 500 MVA 400/220 kV ICT – 1 & 2
7. PMU plot of frequency and phase voltages:

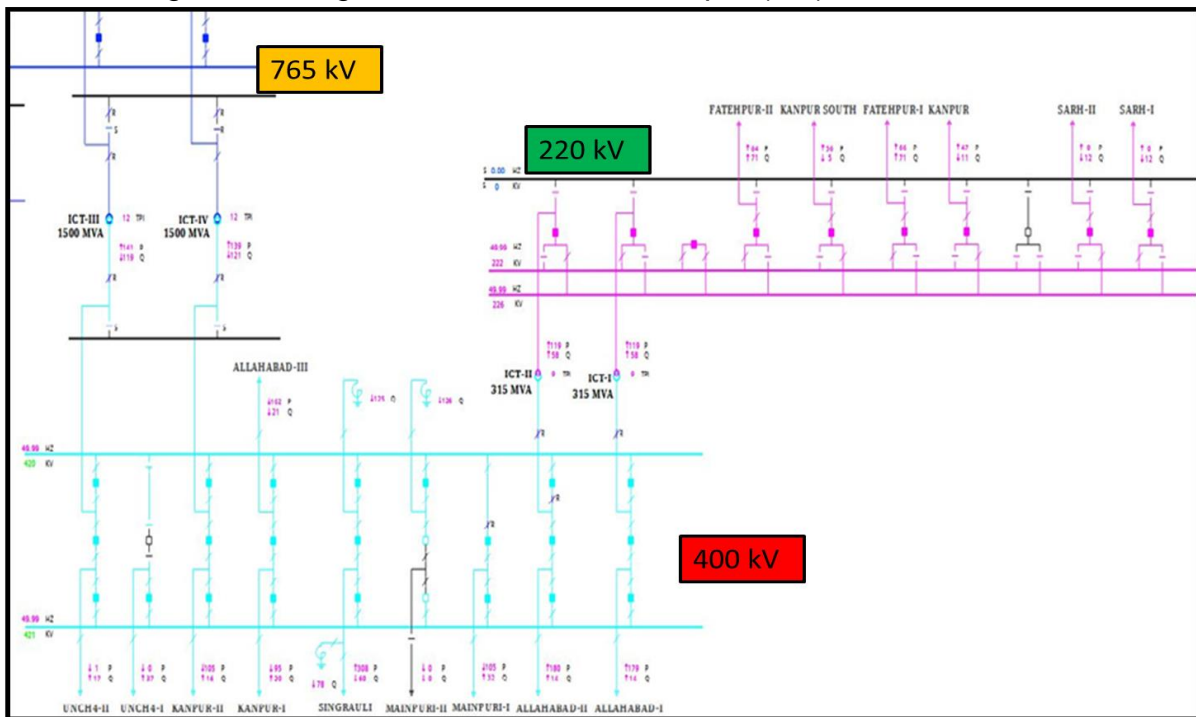
1. Single Line Diagram of 400/220 kV Fatehpur (PG):

2. 400 kV Fatehpur (PG) is connected with Allahabad (PG) triple ckt, Kanpur D/C, Unchahar D/C, Mainpuri PG D/C and Singrauli S/C. It also has two 315MVA 400/220 kV & two 1500MVA 765/400 kV ICT. It has one and half breaker scheme at 400 kV & 765 kV voltage level.

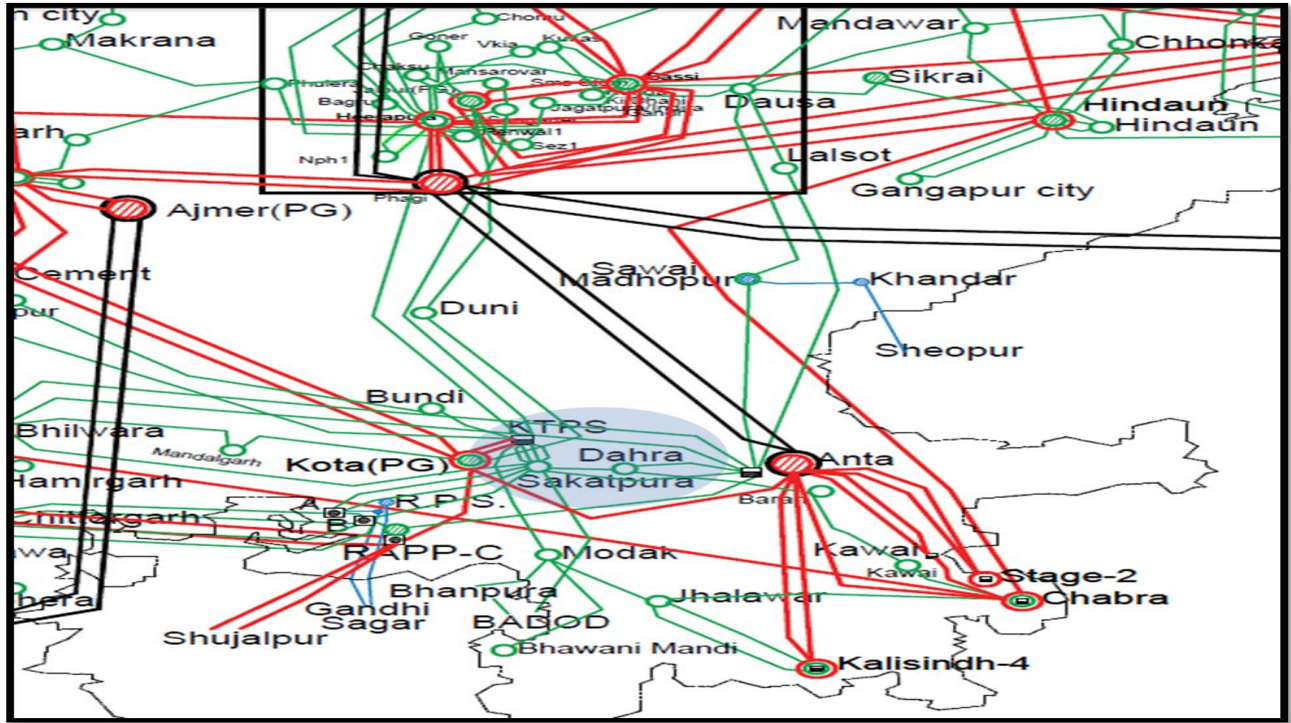
1. 220 kV Kota TPS is connected with Sakatpura four ckt, Kota (PG) D/C, Heerapura S/C, Vatika S/C, Bundi S/C, Beawar S/C, and Morak S/C. Kota TPS has total seven units (capacity of 2x110+3x210+2x195 MW). It has DM (double main single breaker) bus bar scheme. 220 kV buses are sectionalised in total five parts.
2. Connectivity and SLD of 220 kV Kota TPS and 220 kV Sakatpura (Raj):

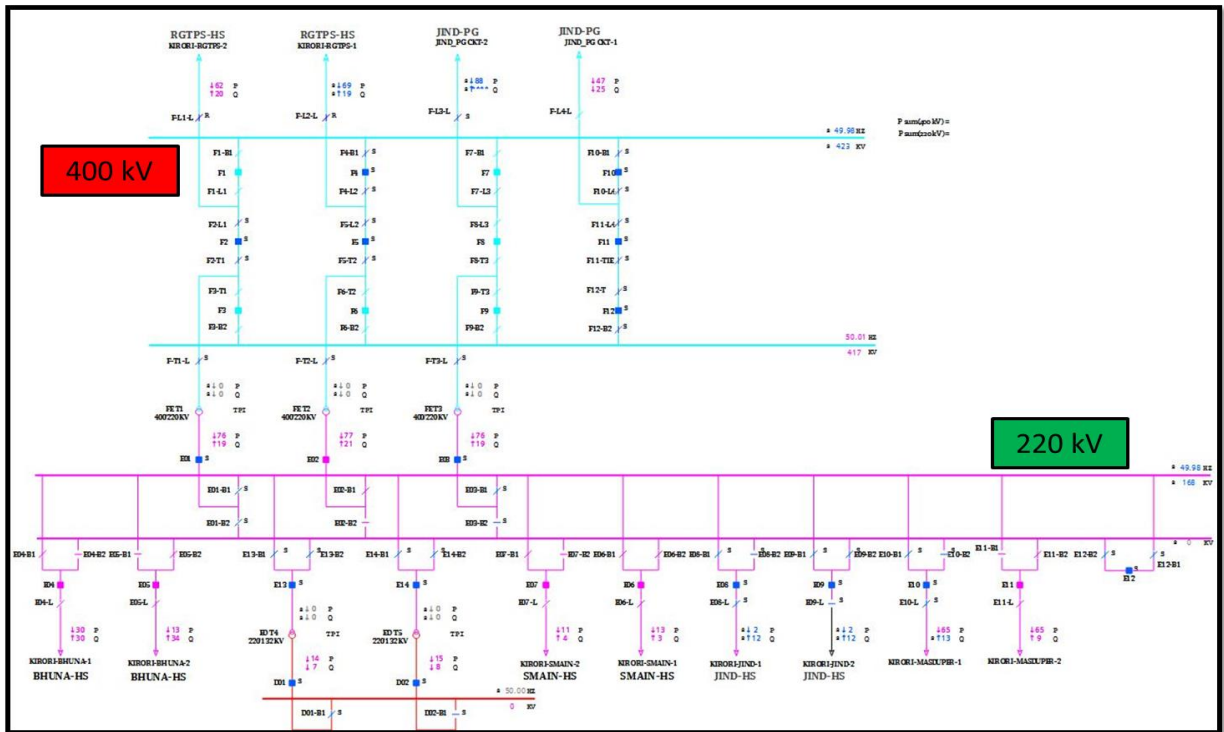
SLD of 400/220 kV Kirori (HVPNL)

2. 400/220 kV Kirori (HVPNL) is connected with Khedar D/C, Jind D/C. It also has three 315MVA 400/220 kV ICTs. It has one and half breaker scheme at 400kV voltage level and DM (double main) bus scheme at 220 kV level. 220kV Kirori (HVPNL) further connected with 220 kV Samain D/C, Masudpur D/C and 220 kV Bhuna S/C.
